Roof Survey Report

September 24, 2008

At the request of XXXXXXXXXXXXXXX, of XXXXXXX University Office of Facilities, The Moriarty Corp. (TMC) conducted an investigation of the roofs of Silliman College, XXXXX University. The inspection included a complete visual survey and defect mapping of the slate and tile roofs of the college, together with the low slope flat-lock lead coated copper (LCC) roofs of the Georgians. The roofs were evaluated to provide a comprehensive profile of their current condition. Visits were made to the buildings during the week of August 18-23, 2008.

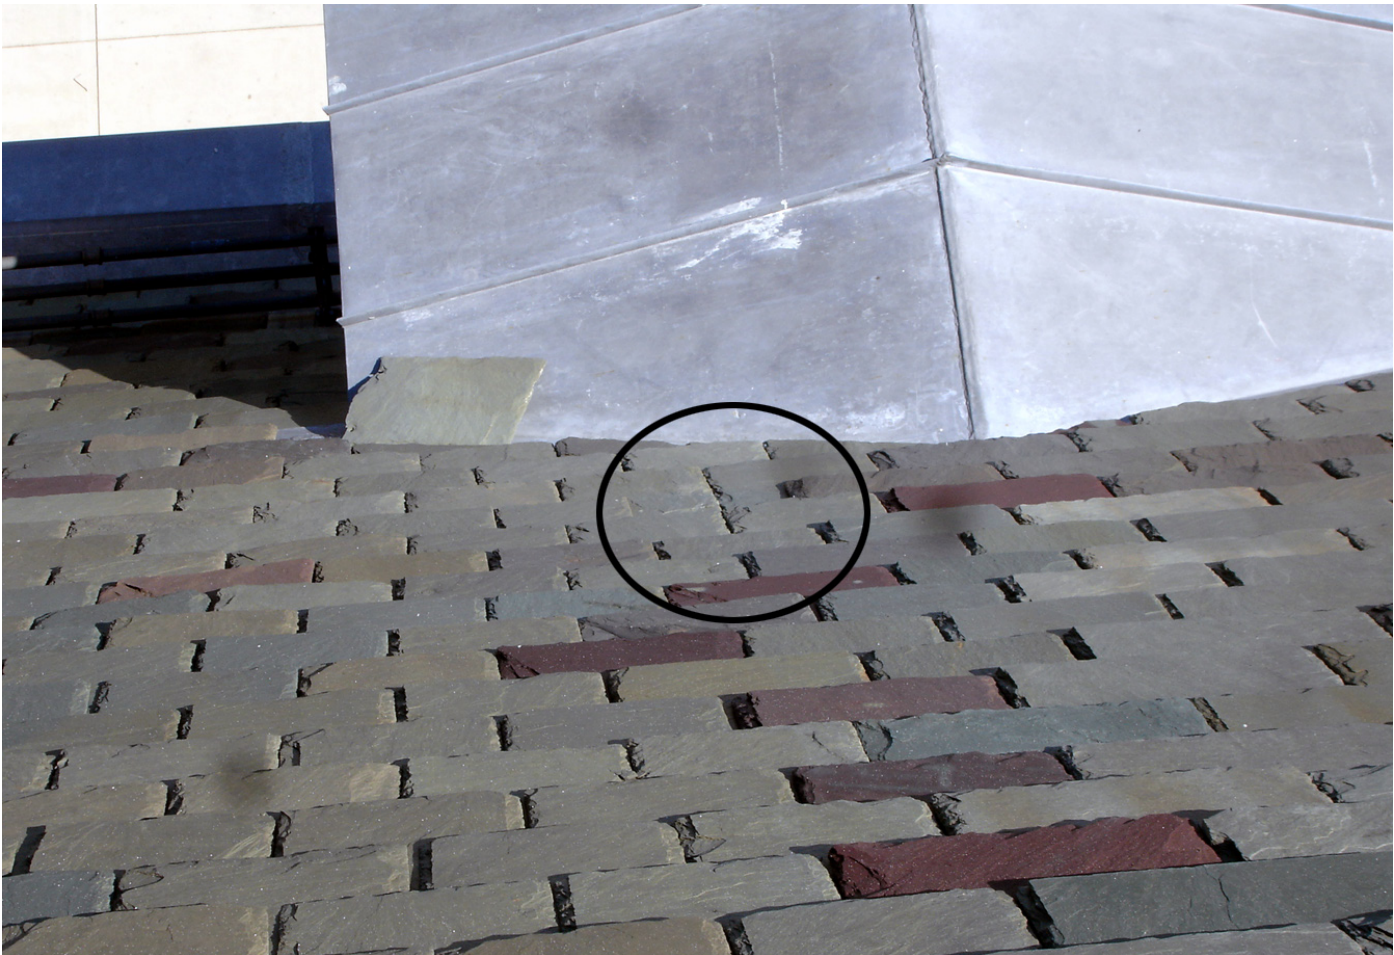
B2: 1 missing slate, slate resting on dormer roof

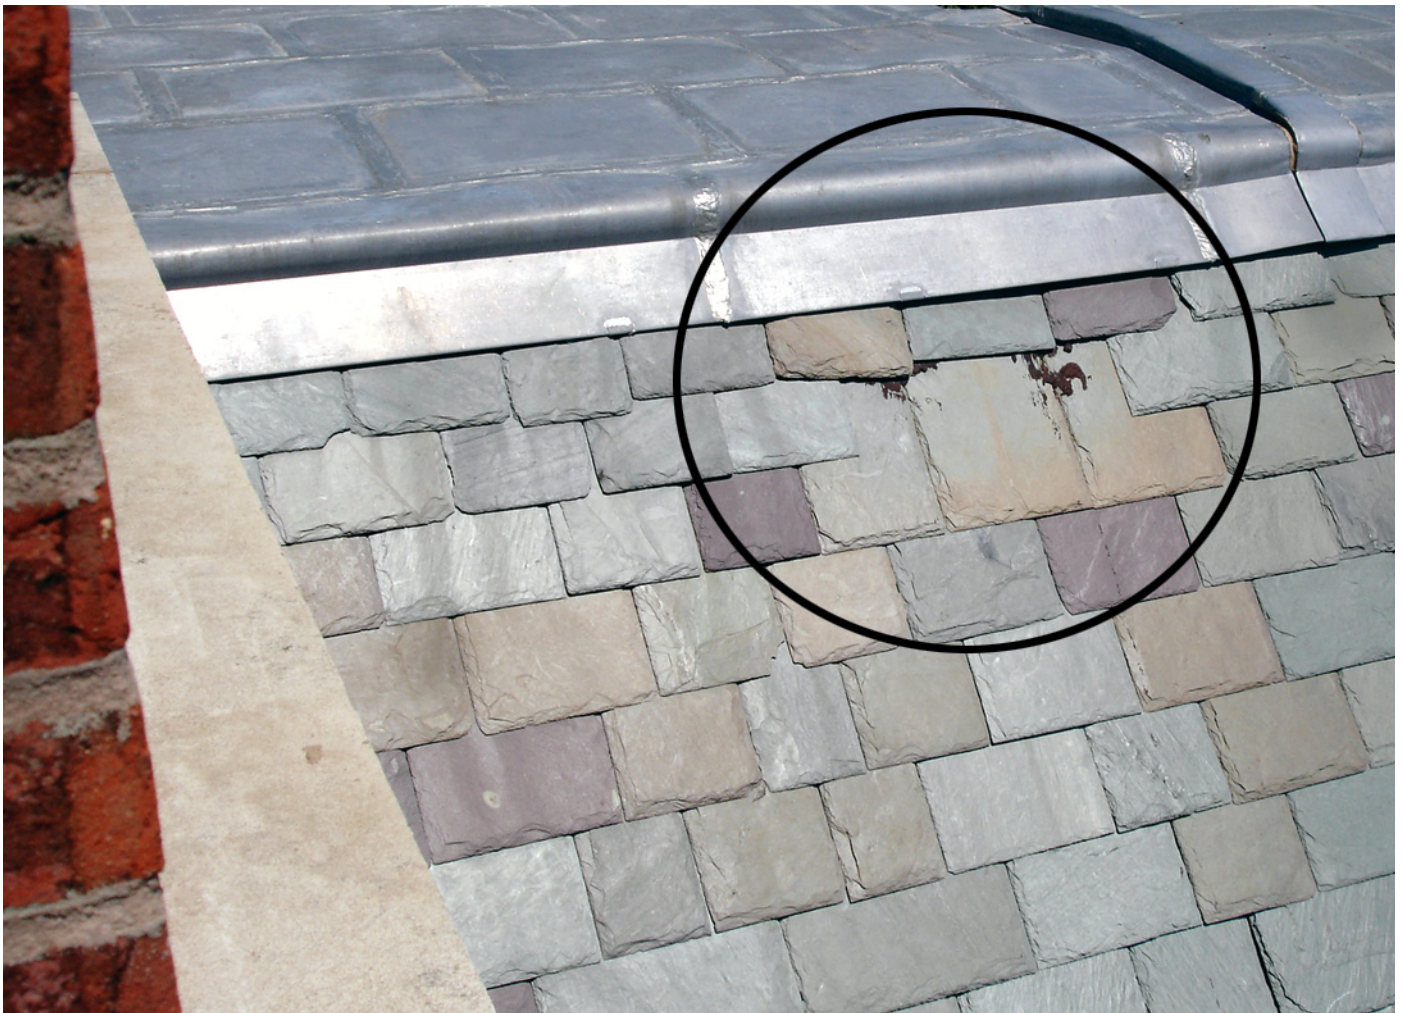
B3: 1 missing slate

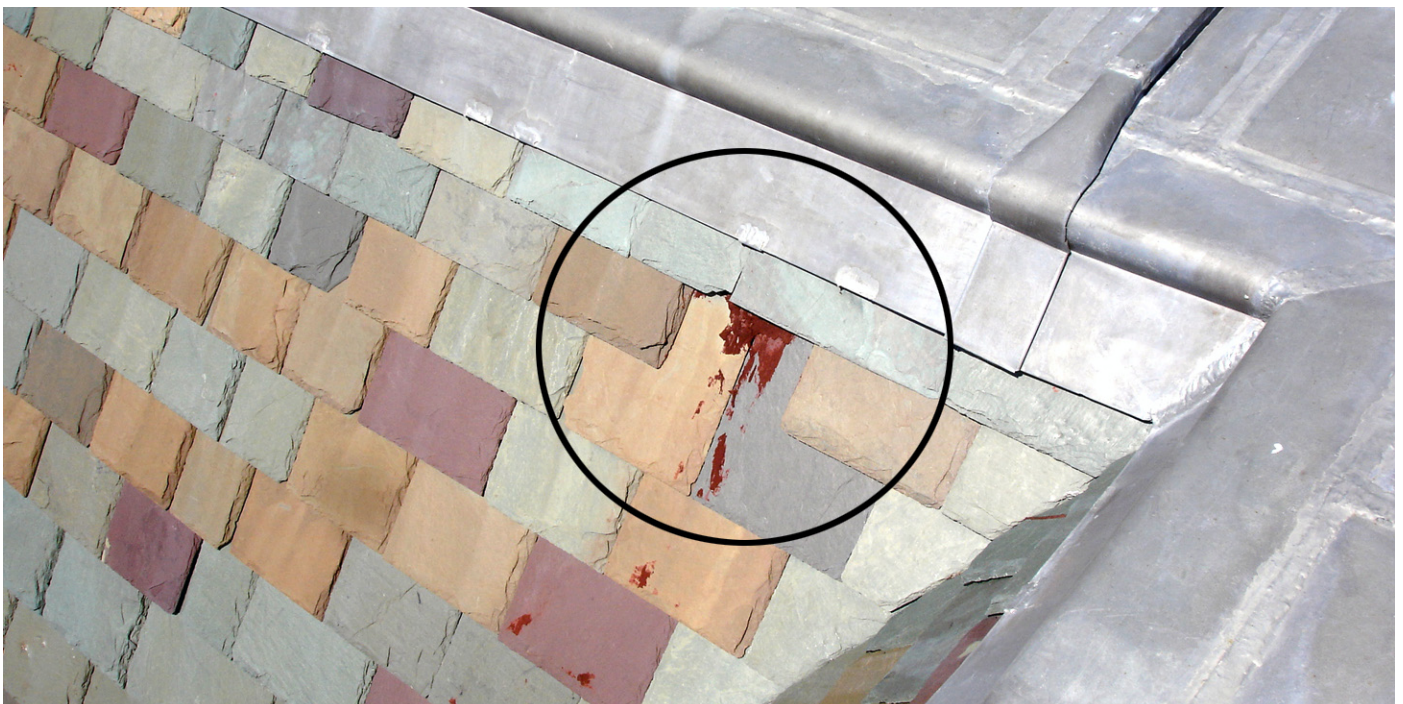
B4: 1 missing slate near ridge

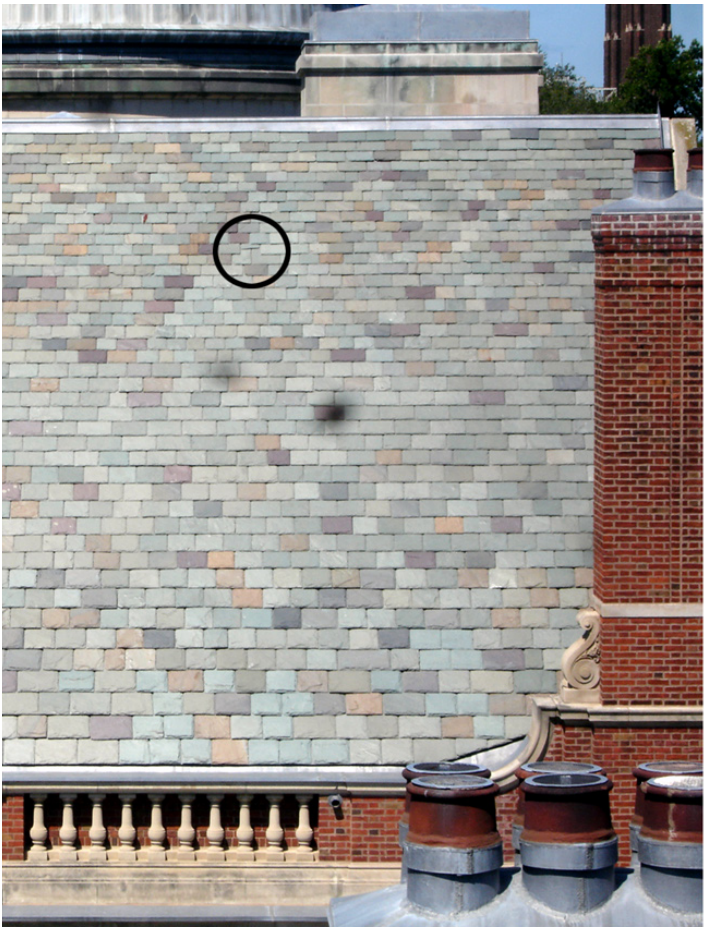
B5: broken slate

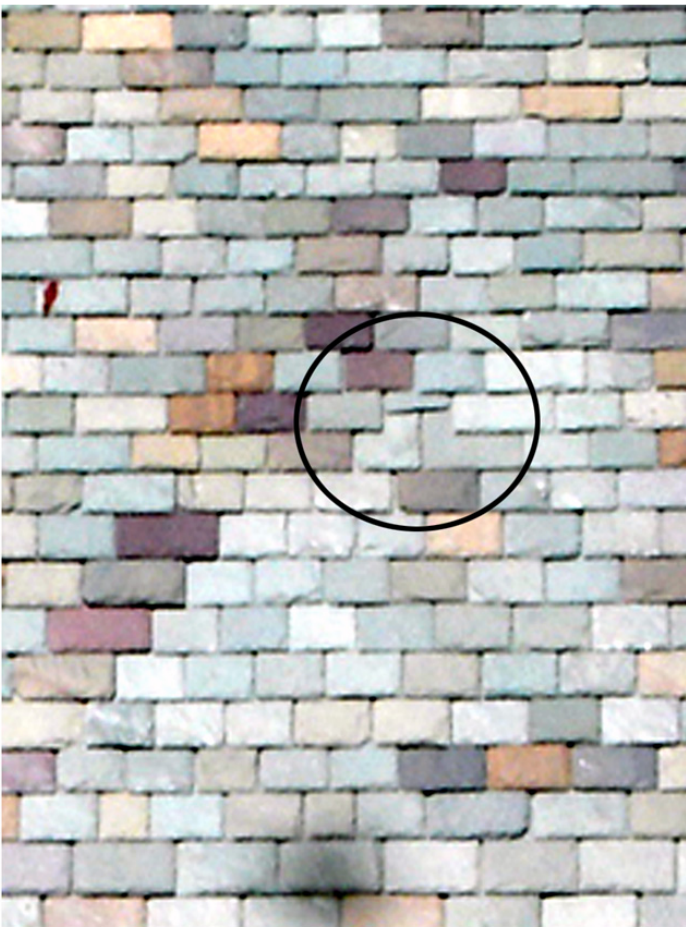
B5: close up of broken slate

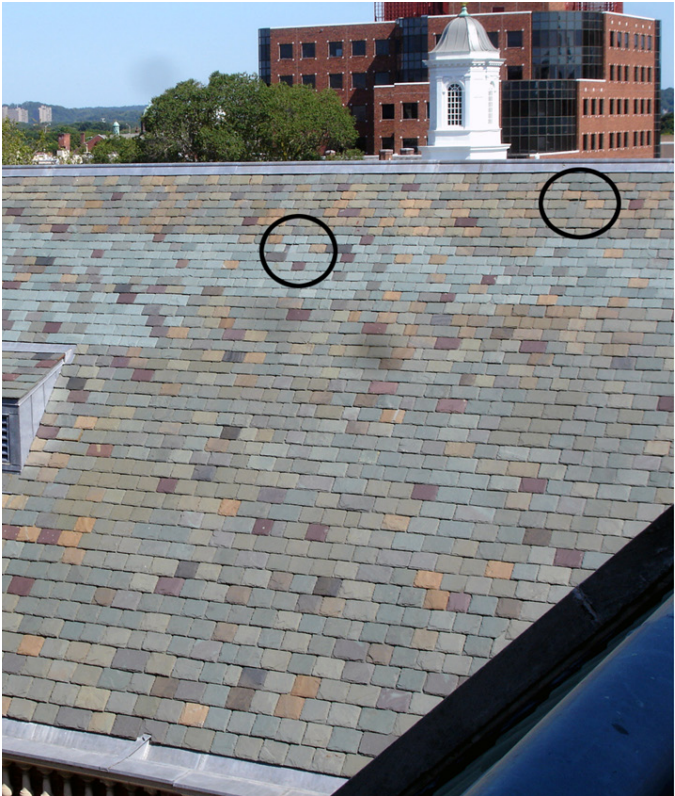
B6: slate missing four courses down from ridge and nine courses down from ridge

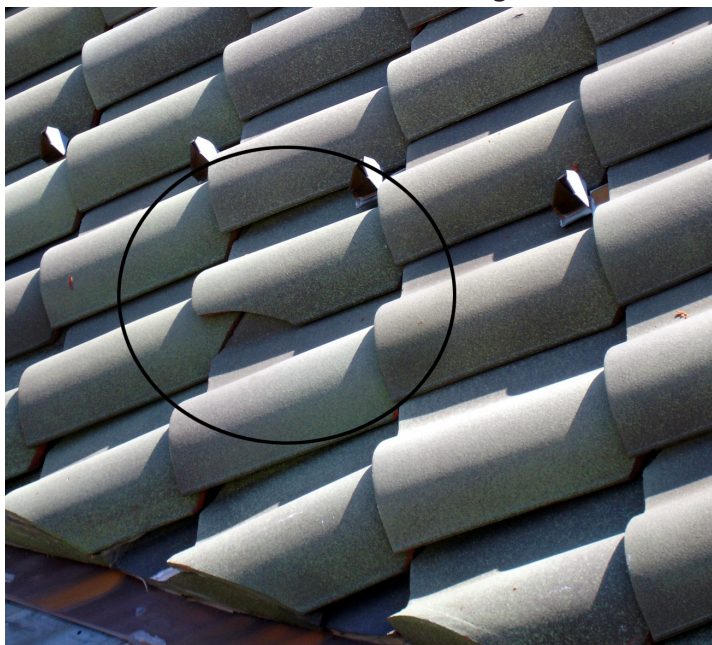
VS3: broken tile

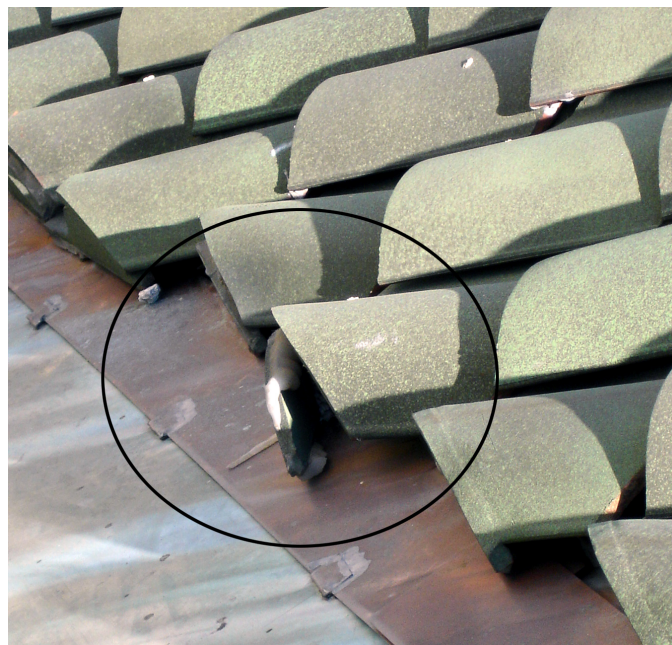
closed valley tile pieces are broken. (Closed valley tile pieces are used at roof valleys. Tiles are cut at the appropriate angle to match the angle of the copper valley. Flat pieces of tile are attached to the cut surface with a liquid clay or slip to close the end of the tile. This tile is fired to form one piece of tile. This attached piece forms a weak point and the pieces of tile were broken at the slip joint.)

As a result of being broken these tiles are open and snow, water, or other intrusions can enter beneath the tile. Possible reasons for tile breakage are foot traffic or a manufacturing defect. The broken cut-and-closed valley tiles may be covered by the tile manufacturer's 75 year limited warranty. We recommend the manufacturer be contacted regarding the warranty coverage.

Past adhesive repairs to the cut-and-closed valley tiles have been made; however, repairs are failing in several locations. For long term performance, new tile pieces matching the angle of the valley should be installed.

VS4: closed valley tile broken, past repair failed

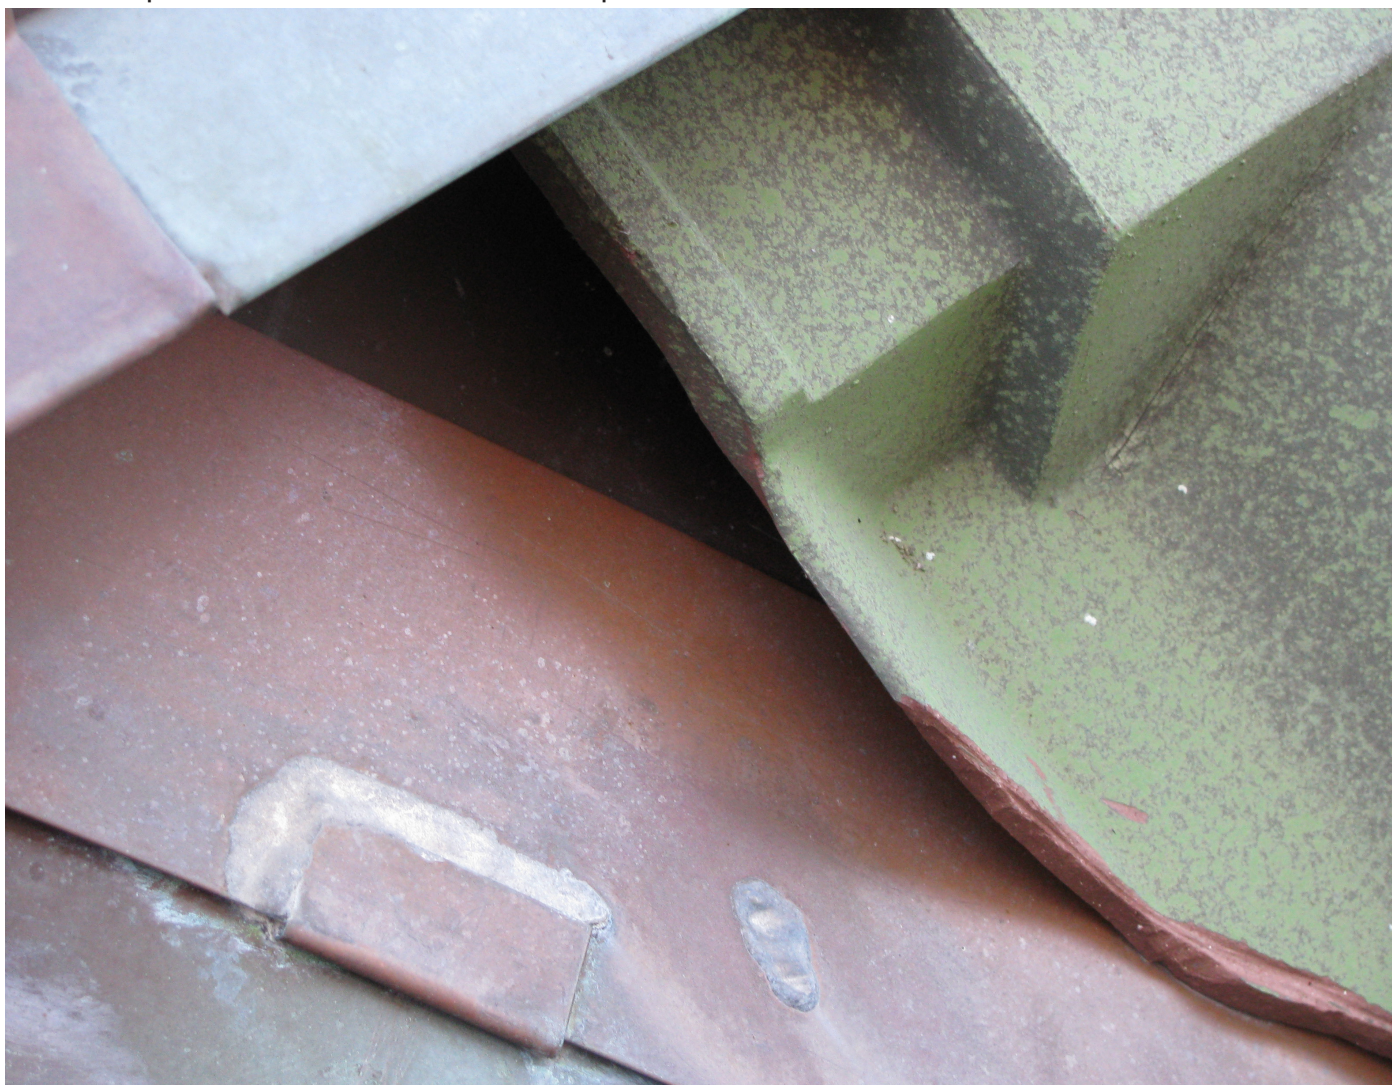
VS6: missing flat top tile piece

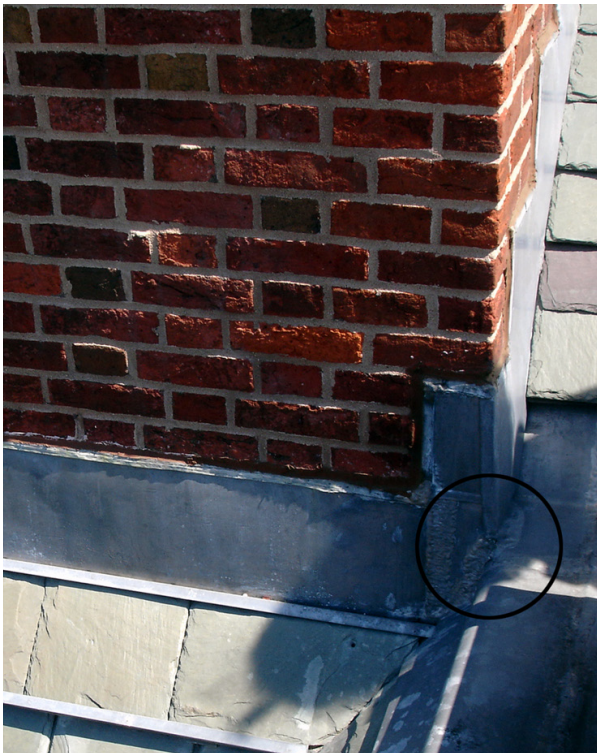
Two solder joint fractures were also observed - one at a chimney corner and one in a low-slope roof area. These solder joints should be re-soldered. Particular attention should be paid to allowances for expansion and contraction in these areas, with additional expansion joints added as needed.

G2: cracked solder

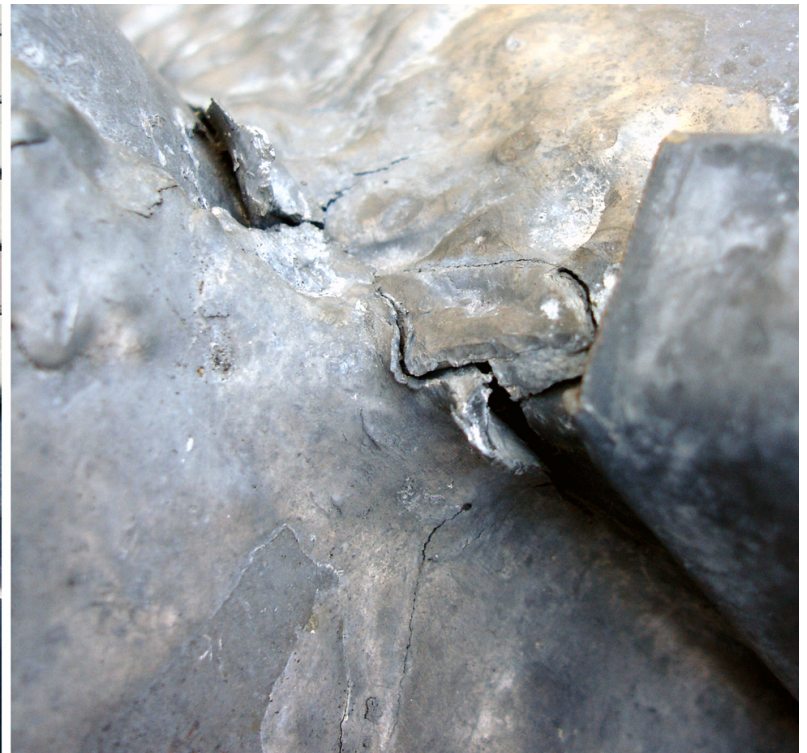
G2: close up of cracked solder

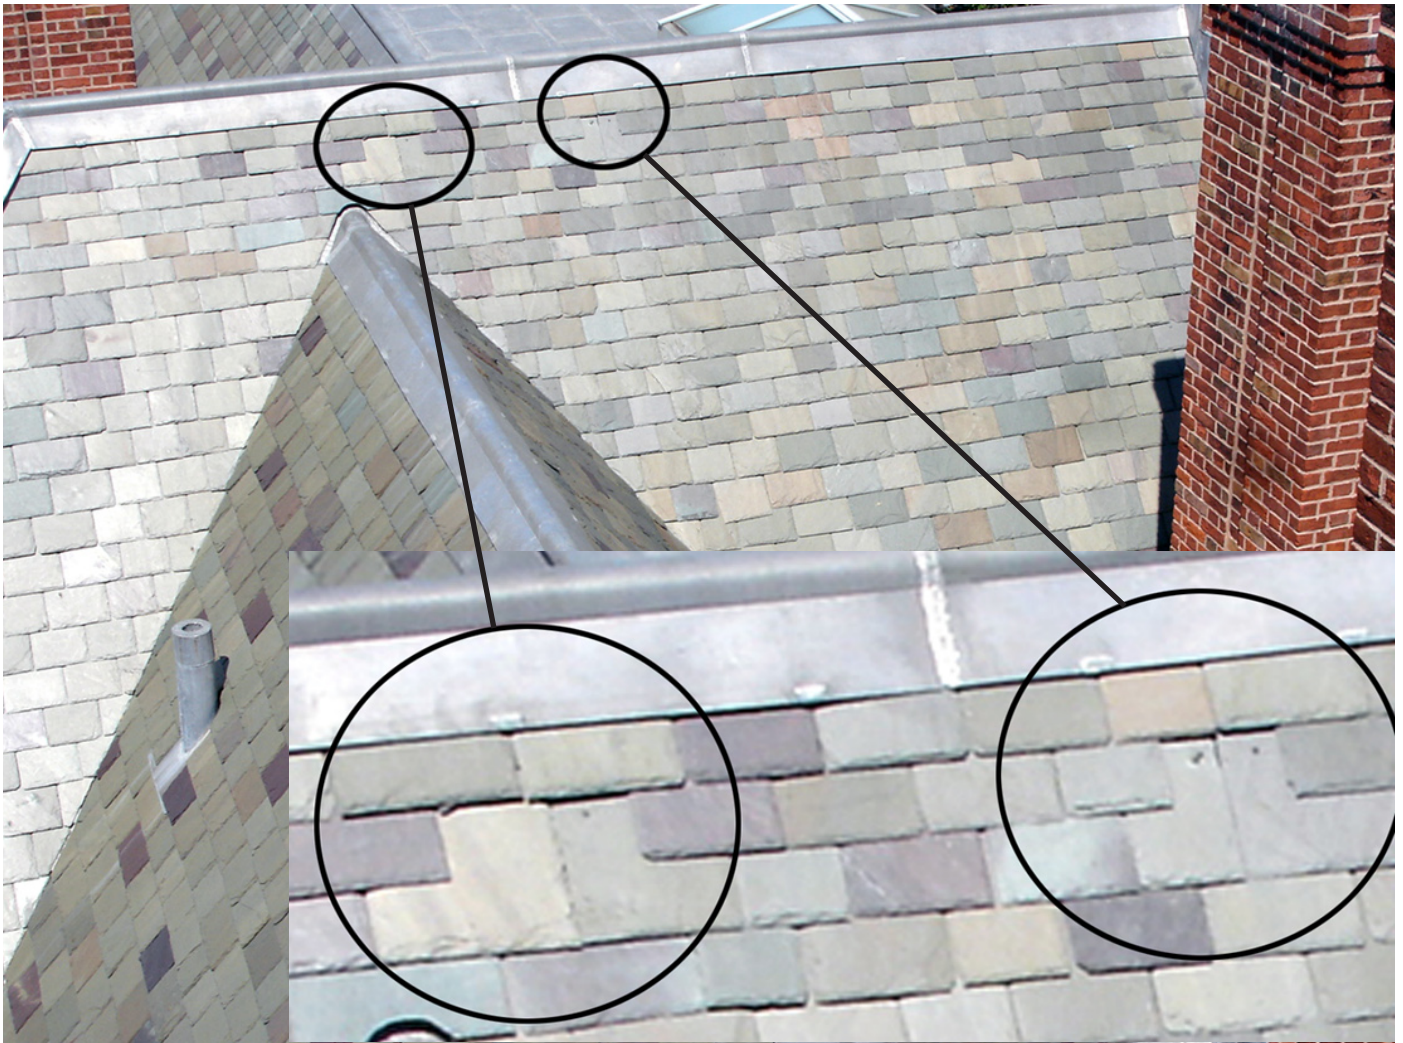
G3: two missing slate two courses down from ridge

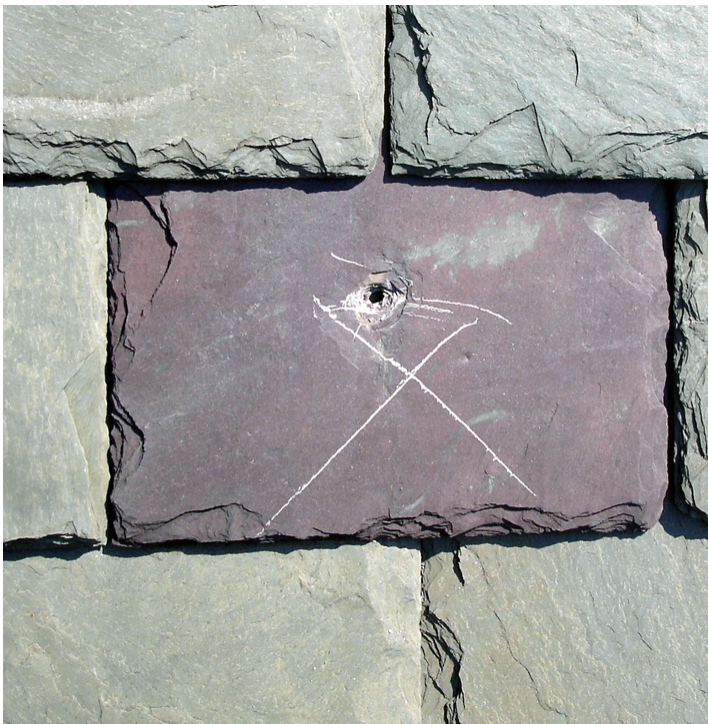
G4: exposed hole in one slate

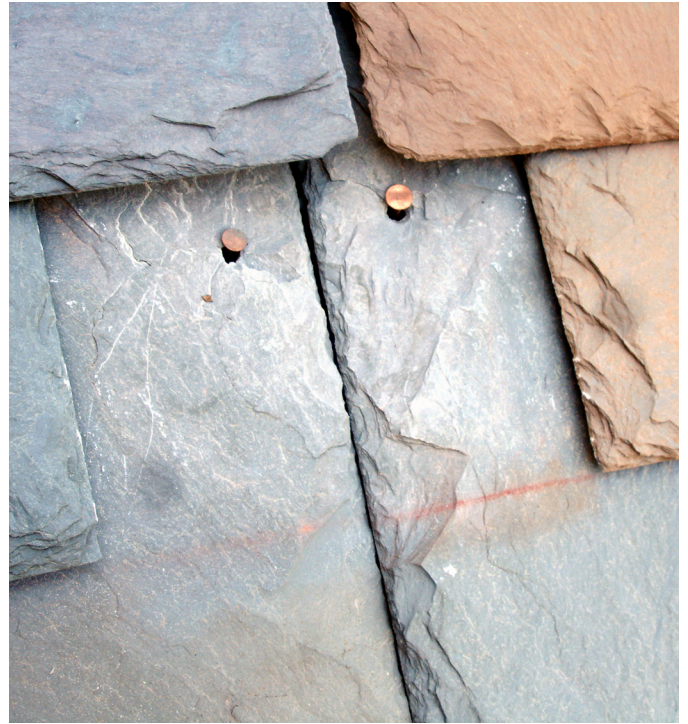
G5: missing slate two courses down from ridge

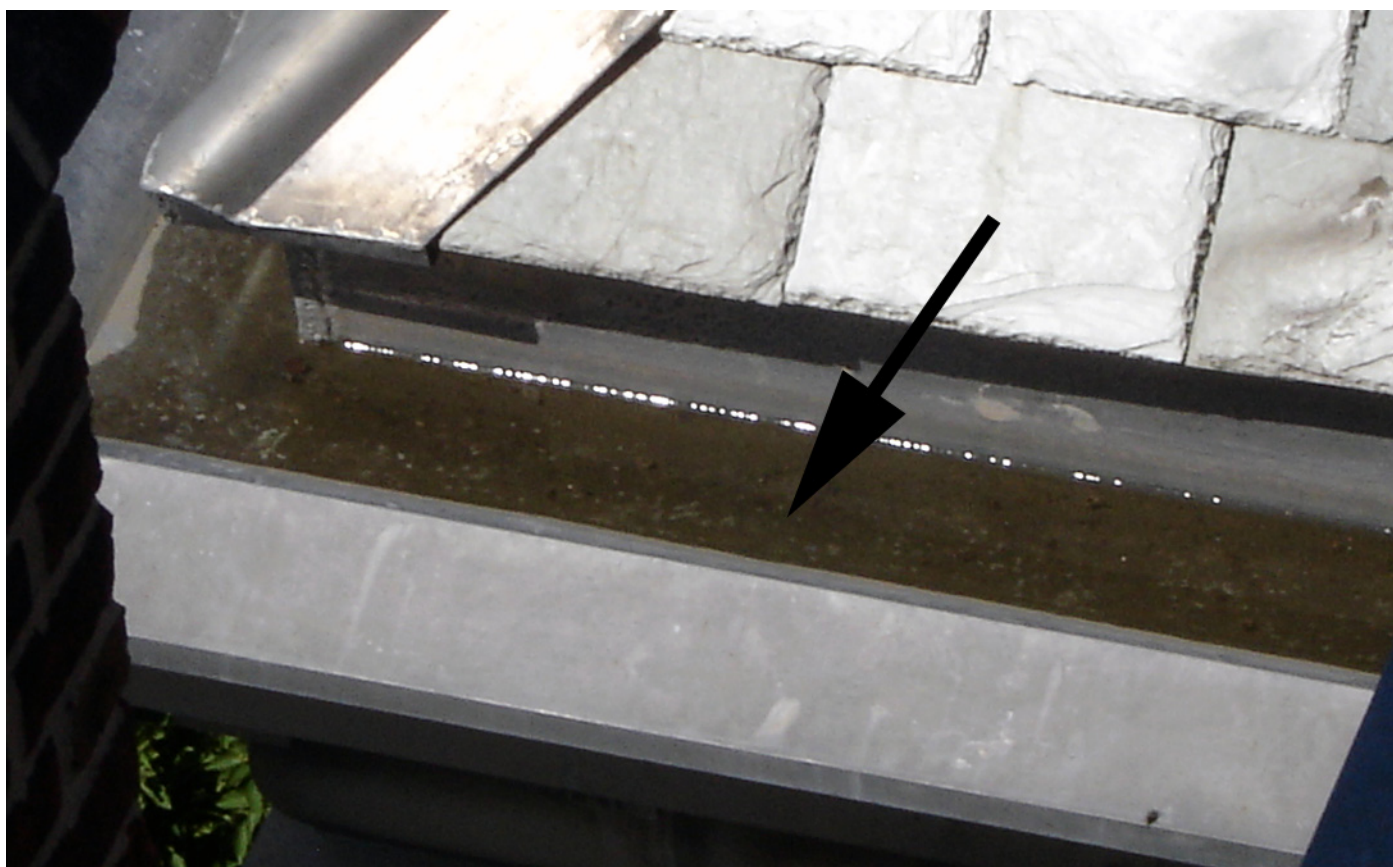
Approximately 6 gutter areas on the Georgians slate roofs were showing clogged gutters with standing water and leaf debris. These gutters should be cleaned out. Debris prevention at the gutter outlets may be advisable, such as the installation of copper strainers in the outlets, if they aren't already in place.

G6: blocked gutter, ponding water

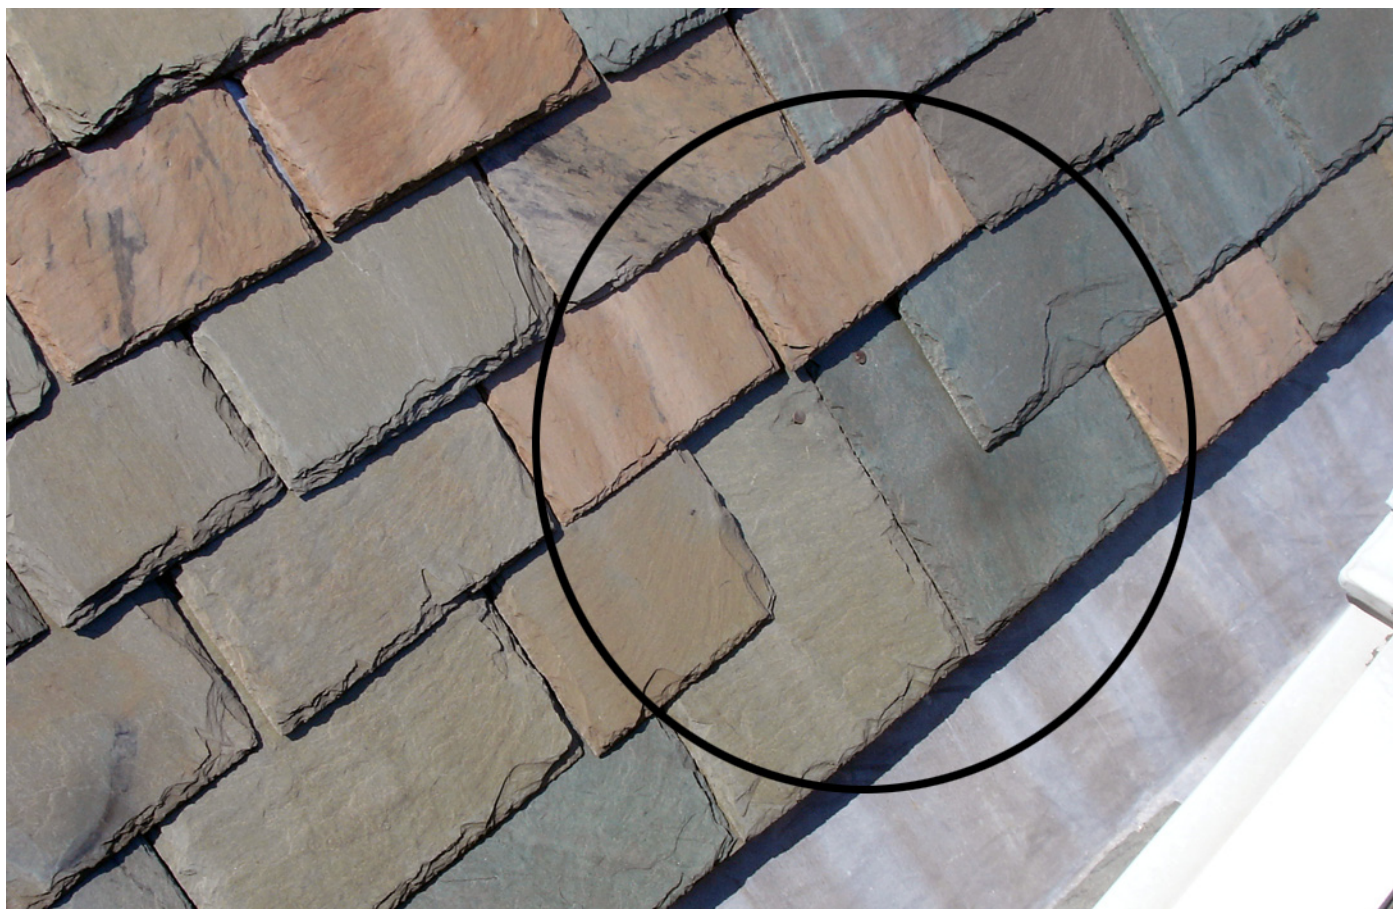
G7: one slate missing

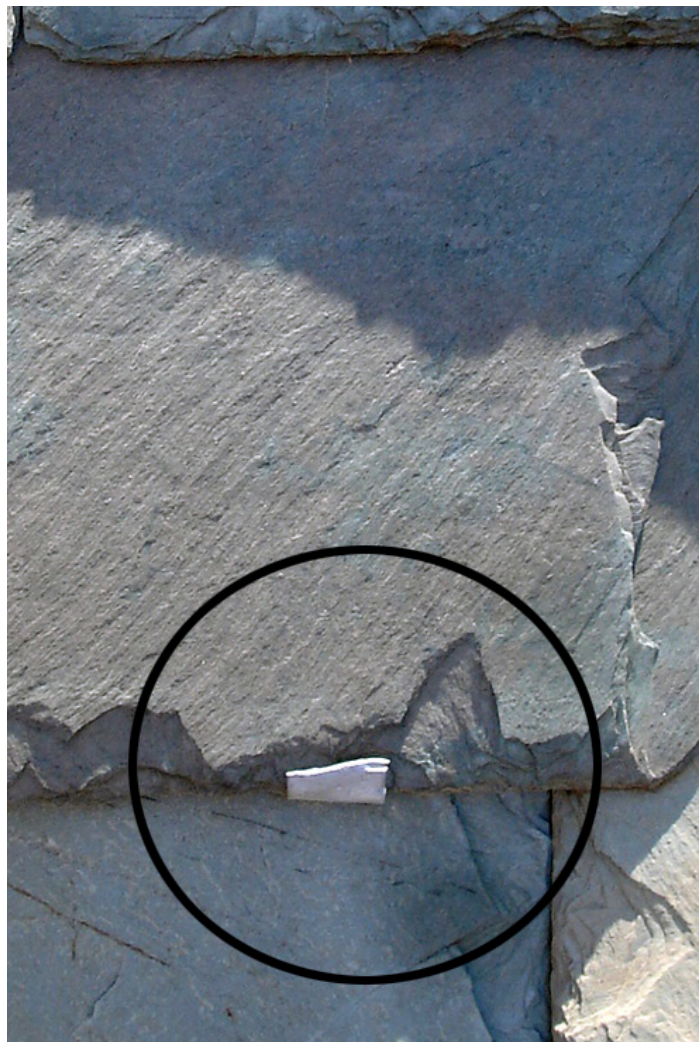
However, a number of faulty slates were observed: 25 slates were broken, missing or sliding out of place. Three additional slates had been replaced using metal straps. A correctly repaired slate will not utilize an exposed metal strap, but instead will use a slate hook or the "nail and bib" slate replacement method. Repair of these slate failures should be covered by the contractor's warranty.

G12: metal strap repair, three observed on roof

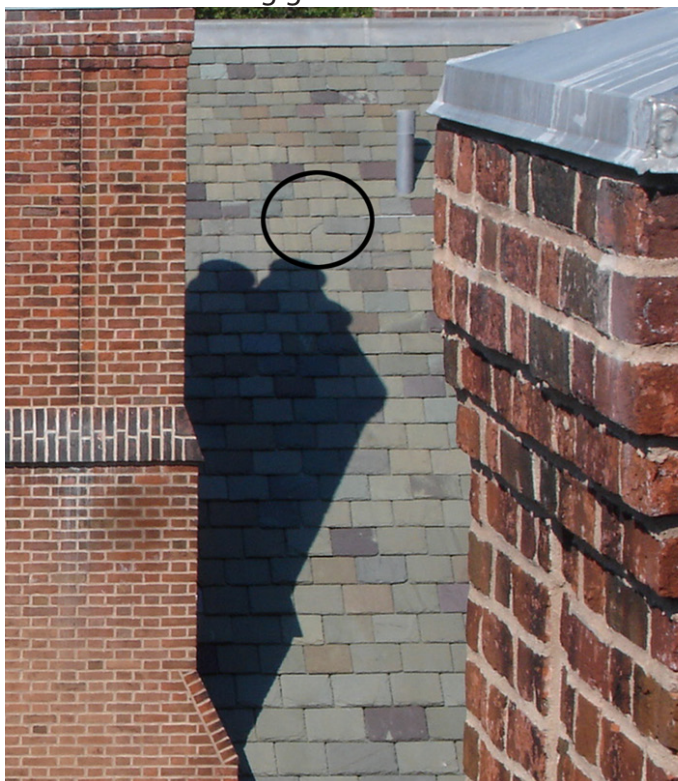
G13: one broken slate

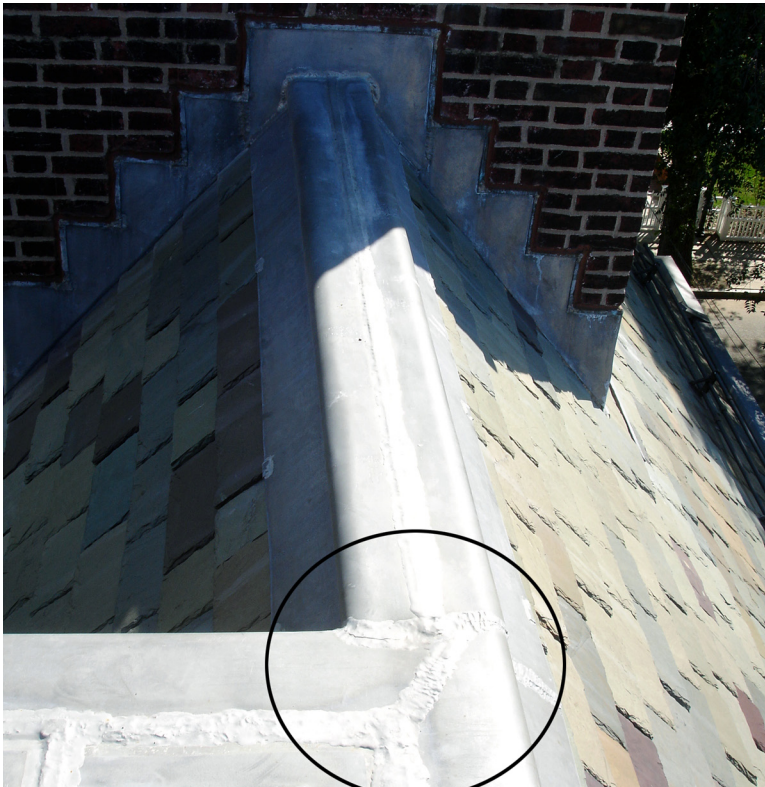
G16: close up of cracked solder joint

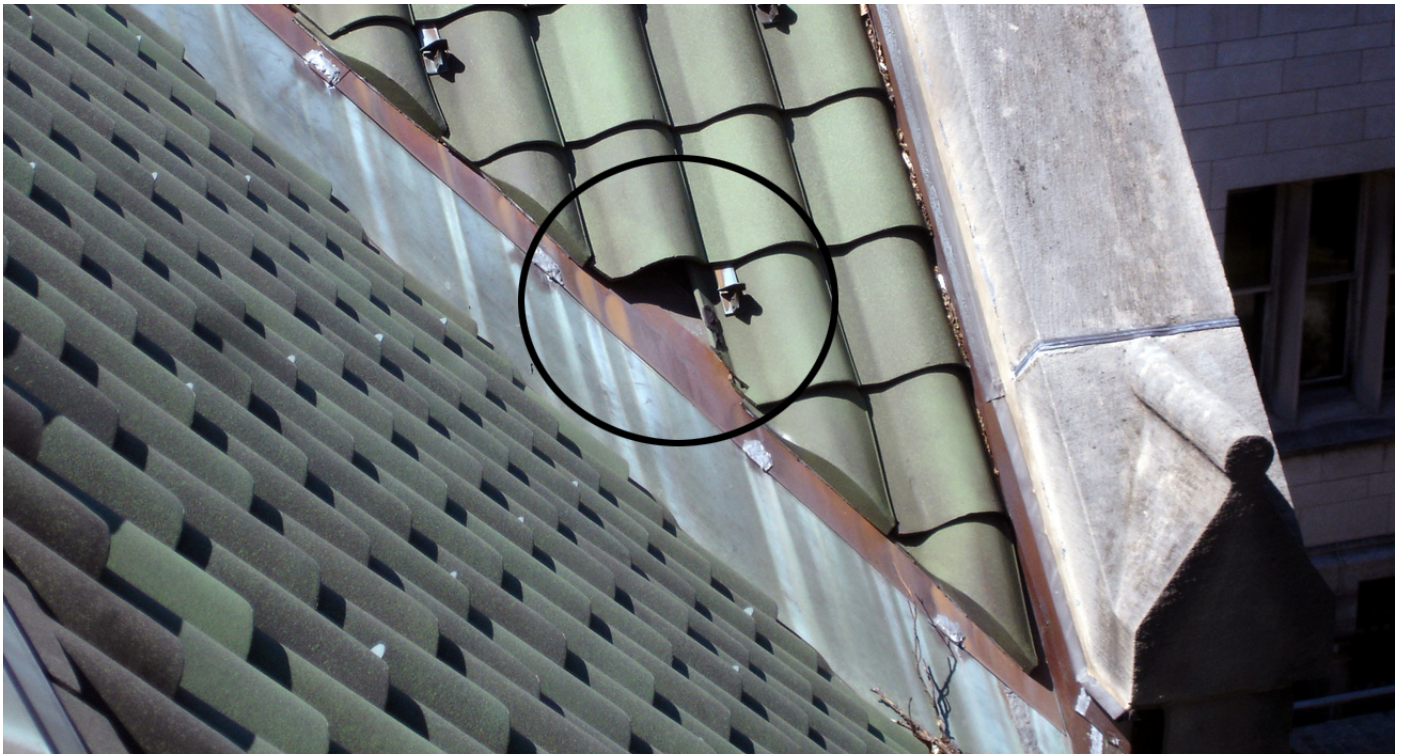
VS7: missing closed valley tile

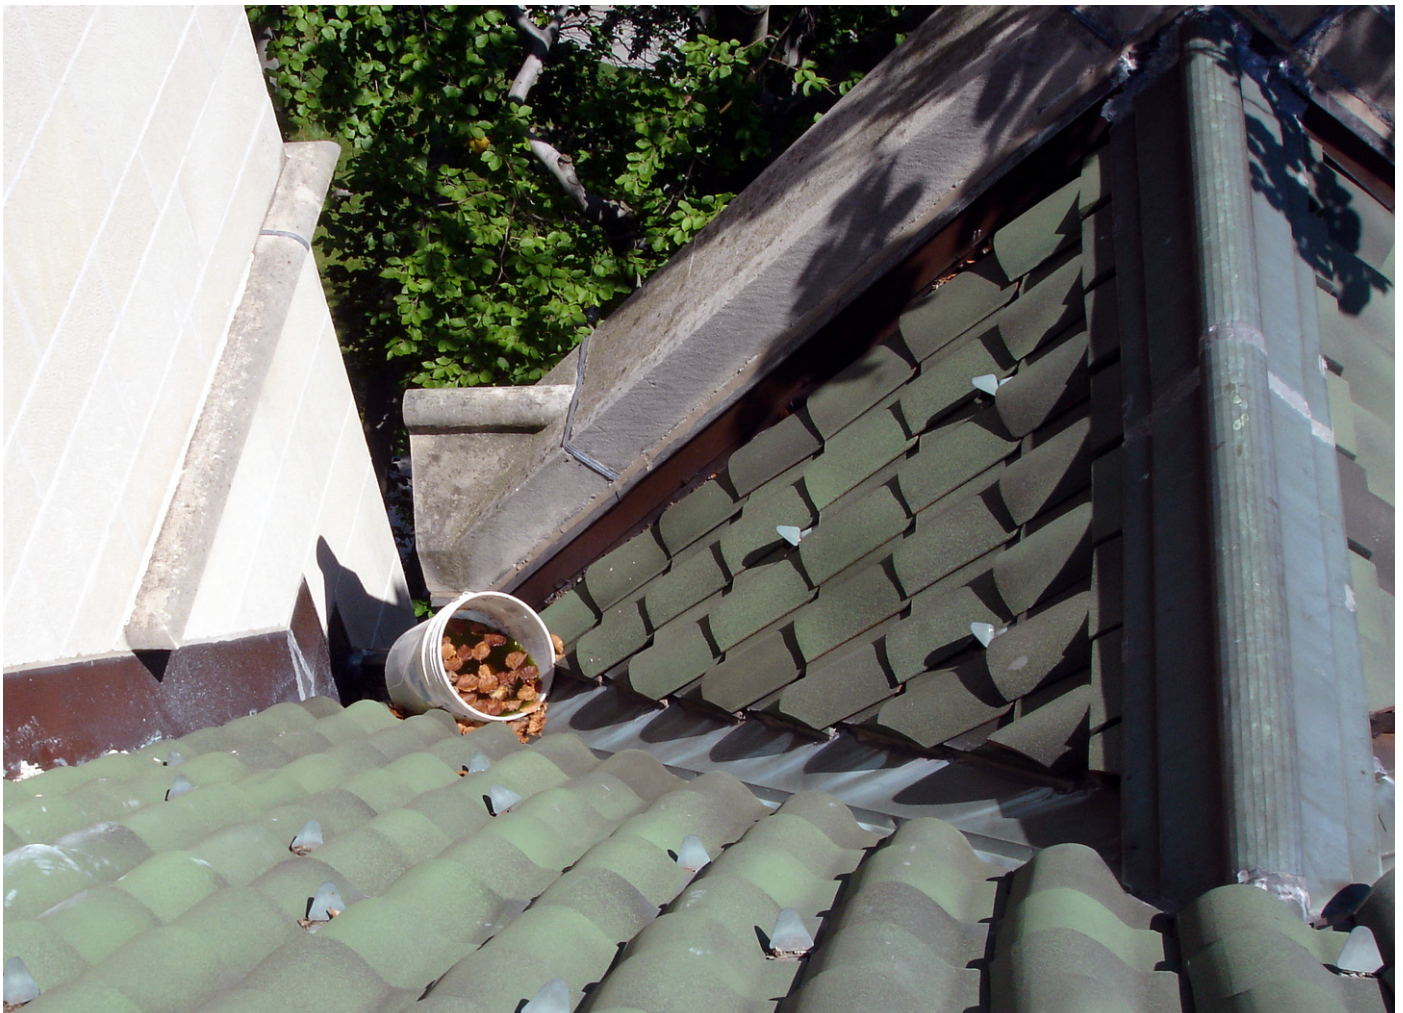
VS8: bucket filled with water is in valley

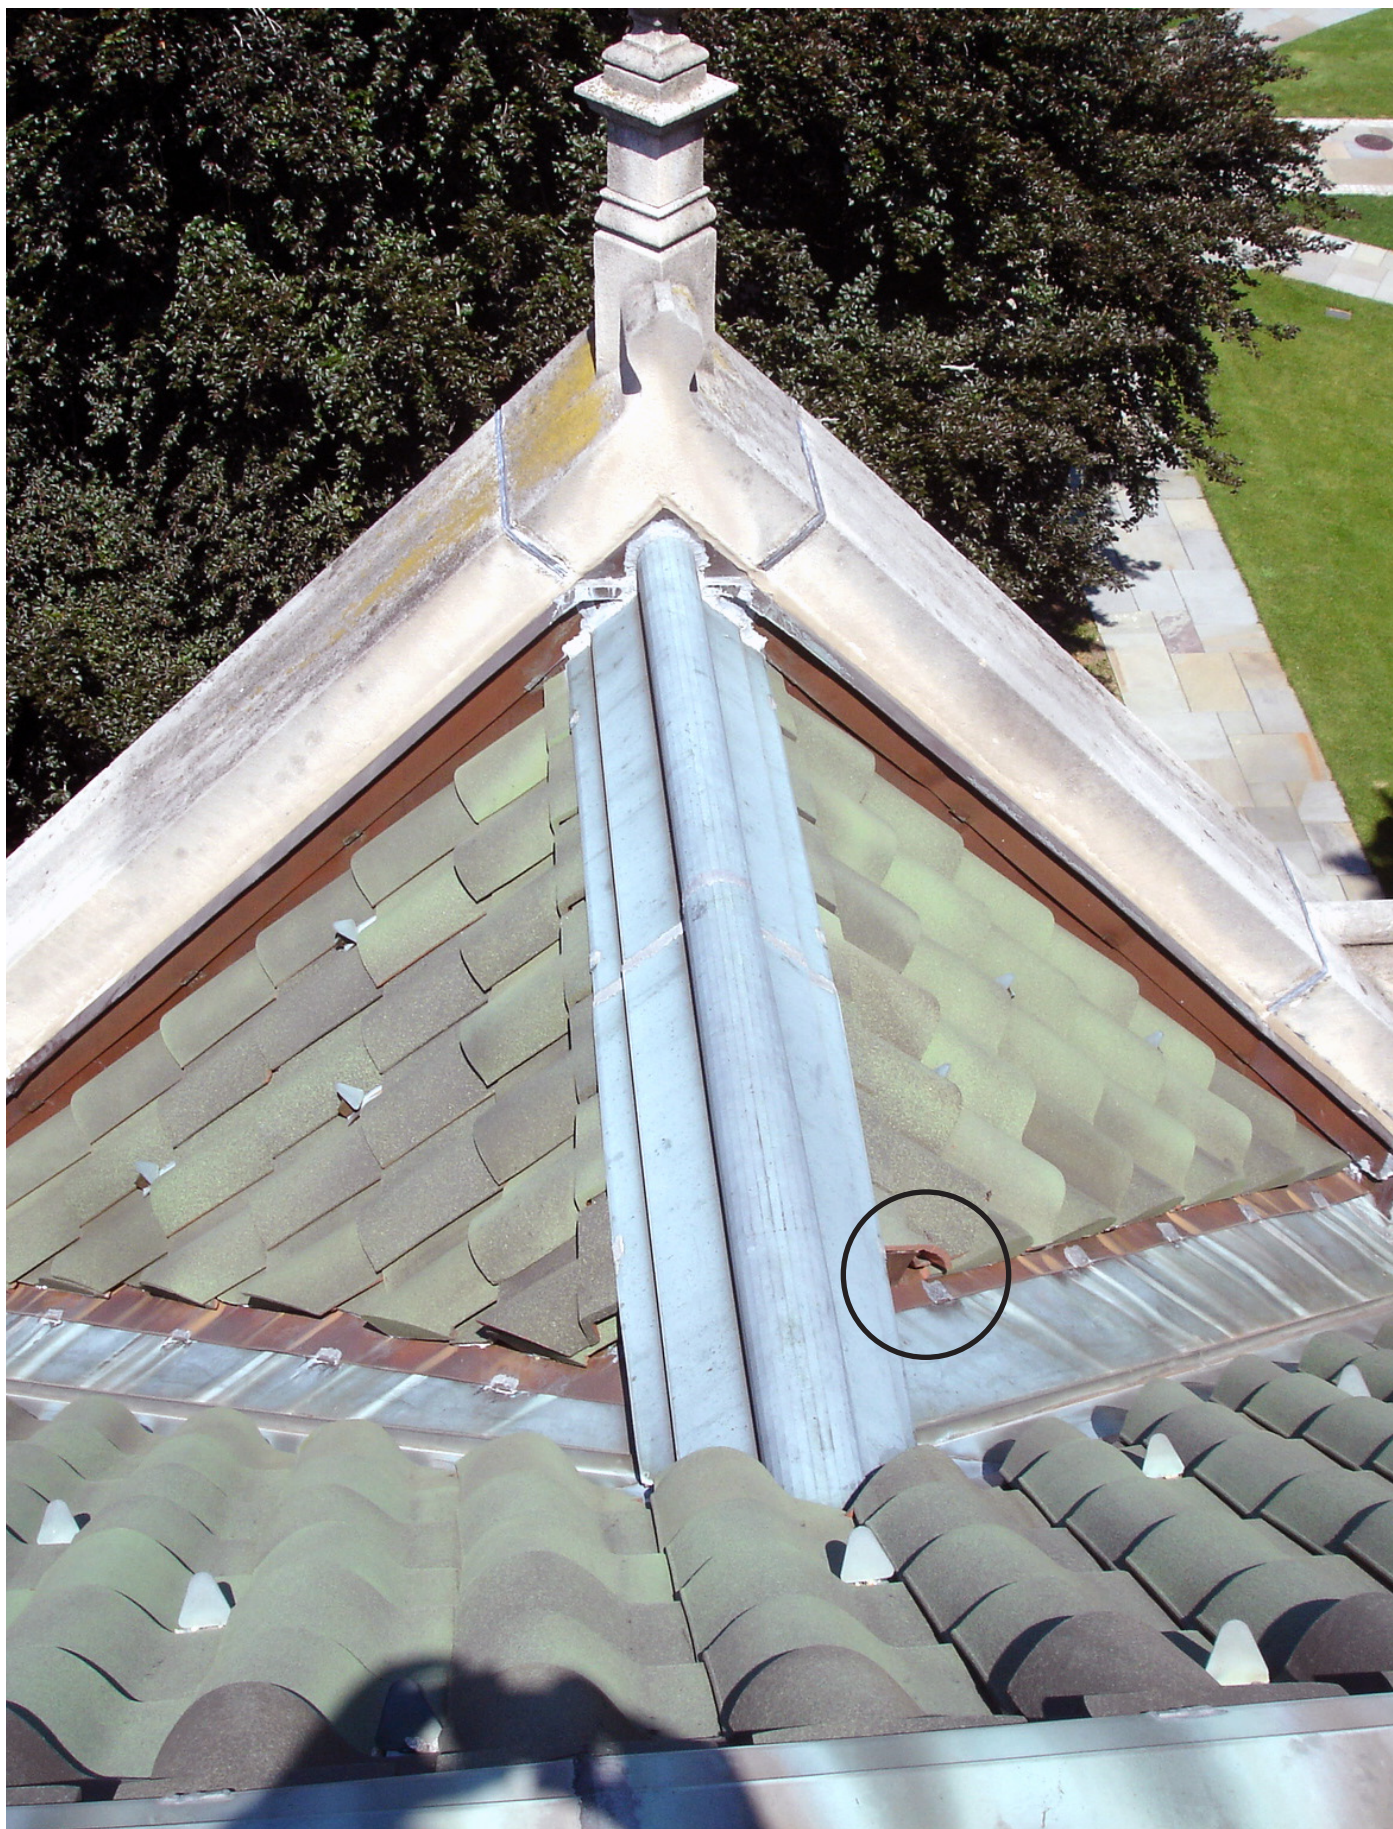
VS9: broken tile

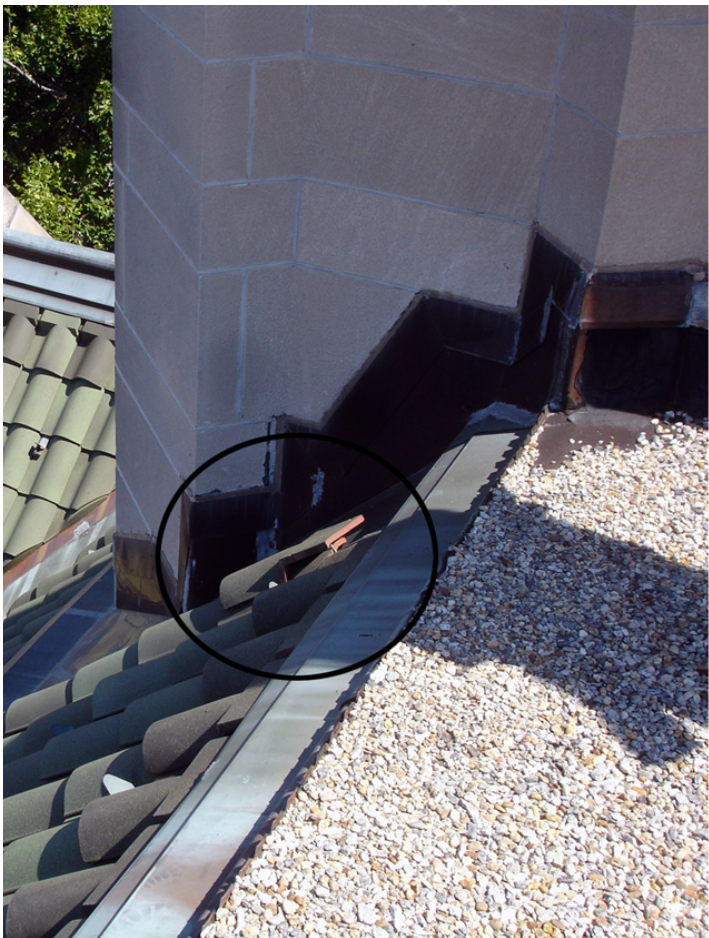
VS10: tile missing, nailer exposed

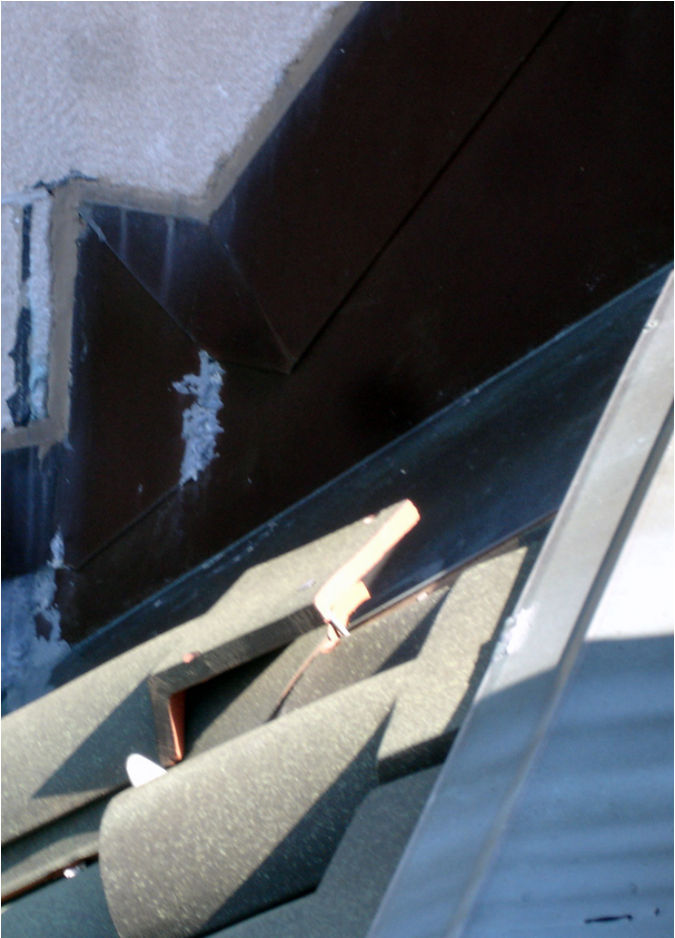
VS10: close up
