Roof Survey Report

September 24, 2008

At the request of XXXXXXXXXXXXXXX, of XXXXXXX University Office of Facilities, The Moriarty Corp. (TMC) conducted an investigation of the roofs of Silliman College, XXXXX University. The inspection included a complete visual survey and defect mapping of the slate and tile roofs of the college, together with the low slope flat-lock lead coated copper (LCC) roofs of the Georgians. The roofs were evaluated to provide a comprehensive profile of their current condition. Visits were made to the buildings during the week of August 18-23, 2008.

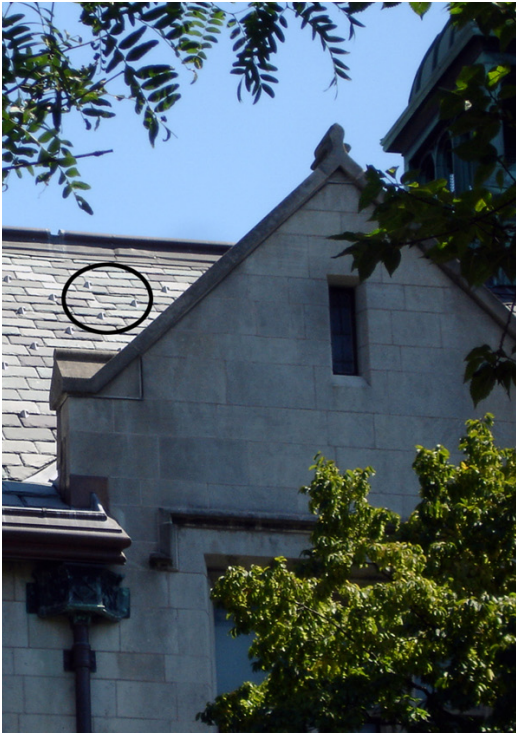
C1: cracked slate

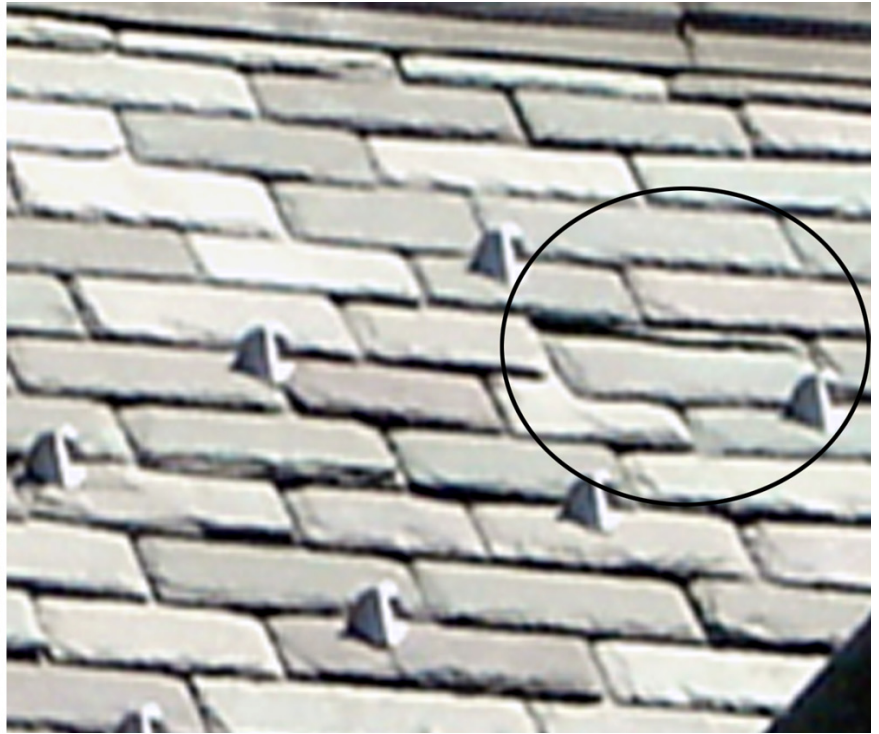
C1: close up of cracked slate

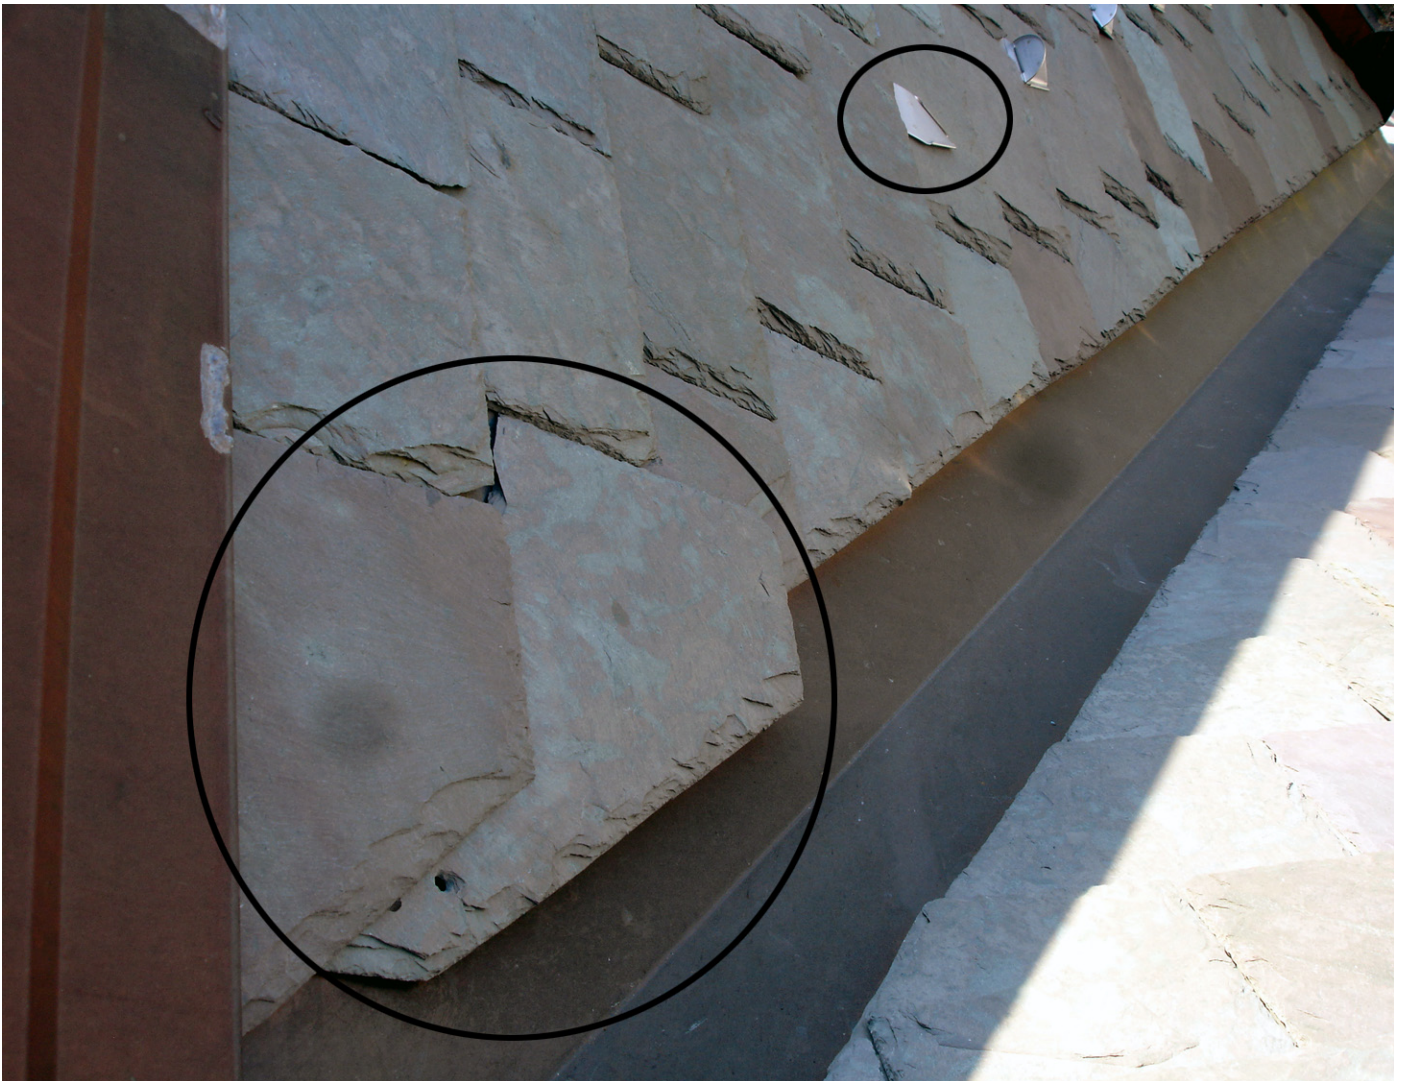
C2: slipping slate; smaller circle shows flattened snow guard

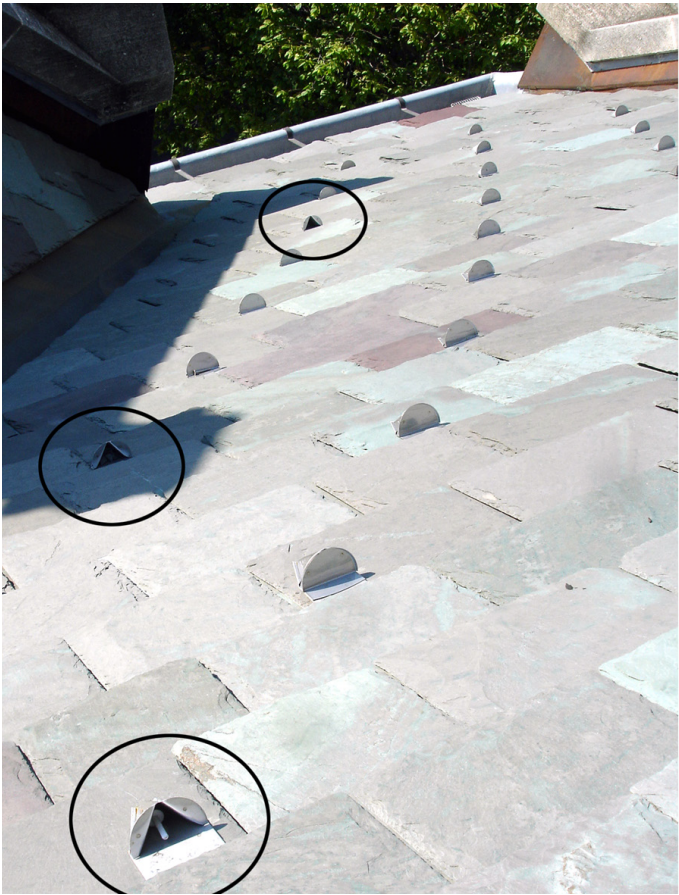
A number of snow guards are failing because the snow guard pad has broken or unfolded under snow loads. Retro-fit snow guards are available and a warranty for their performance can be obtained. It may be possible to eliminate the pad-type snow guards with the installation of a pipe style snow retention system. We recommend a 3-pipe style snow retention system with expanded stainless steel metal backing attached to the horizontal rails. The mesh can catch falling objects should tile or tile fragments become dislodged from the roof over time.

C4: broken snow guards

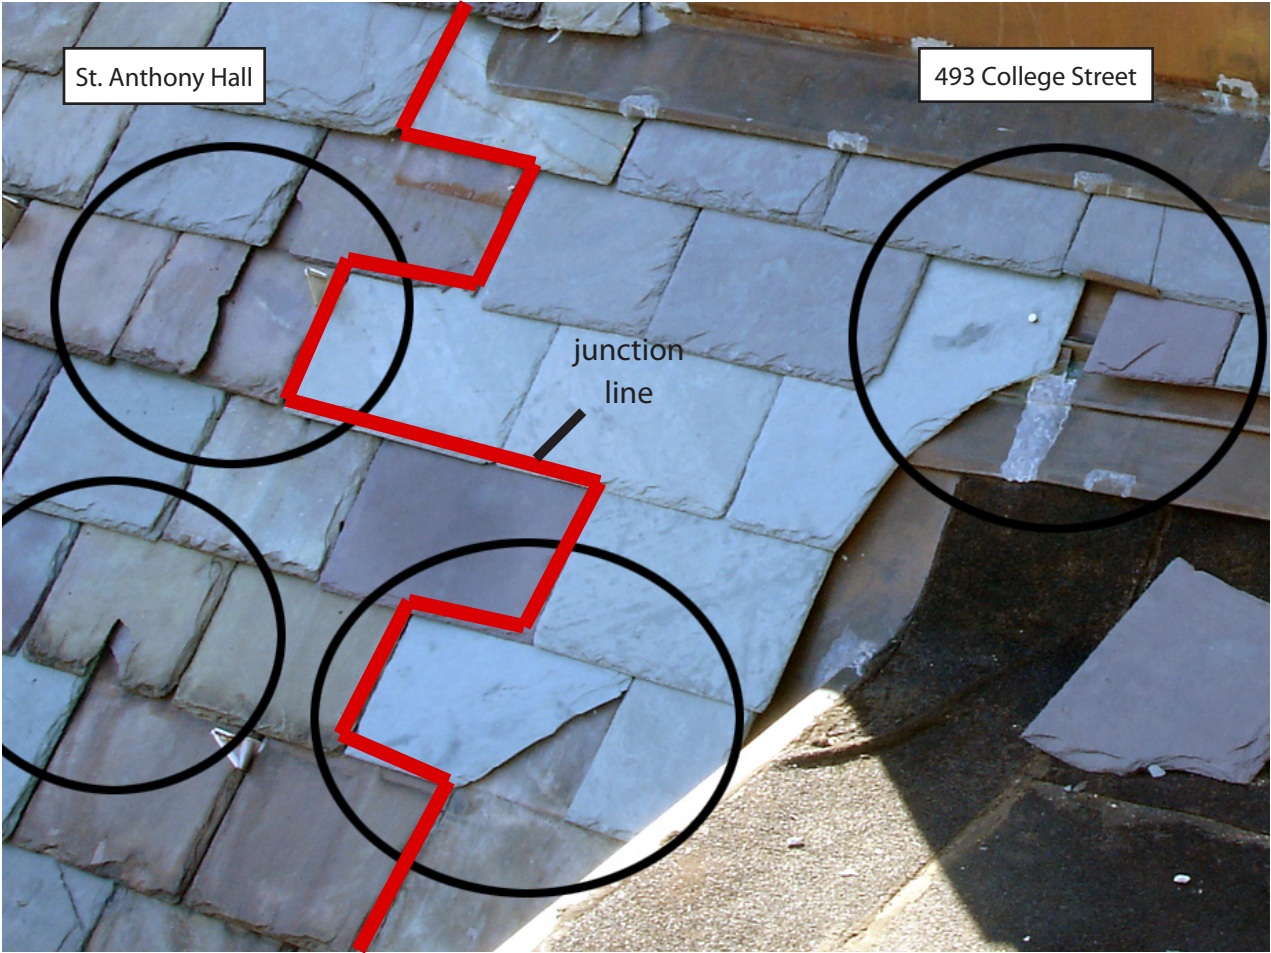
C6: missing and broken slate

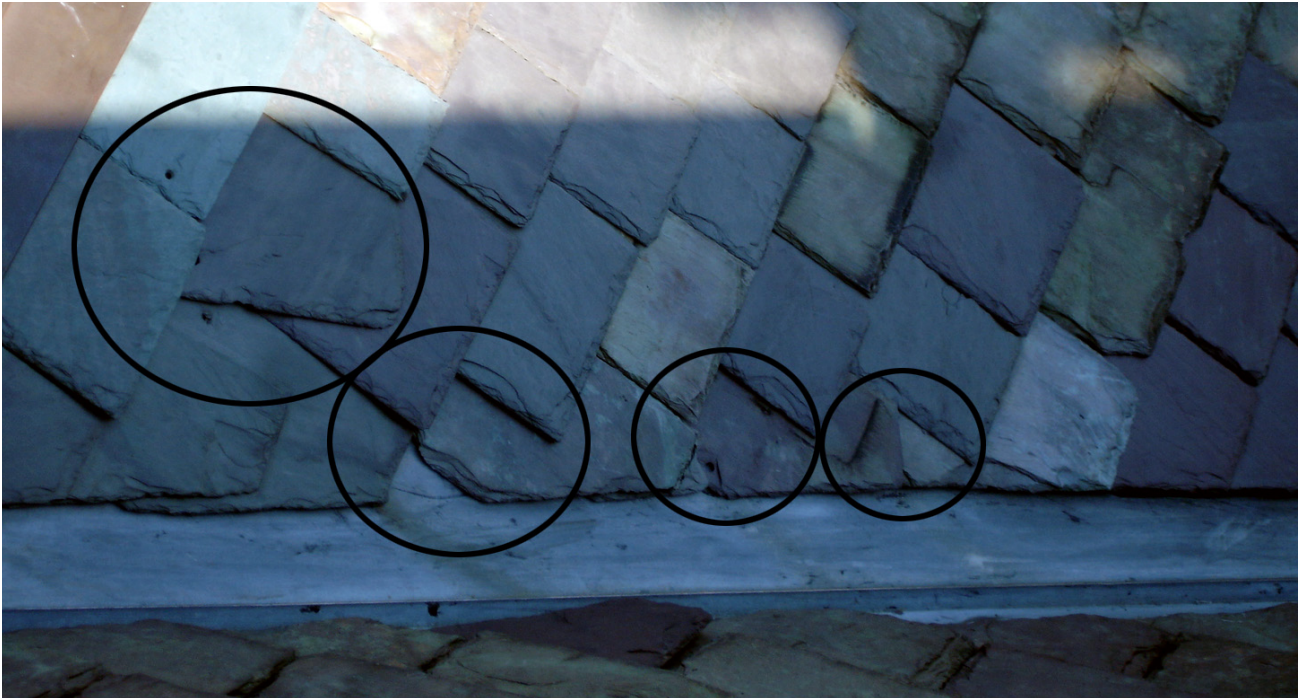
C7: broken and missing slate (portion of original slate roof)

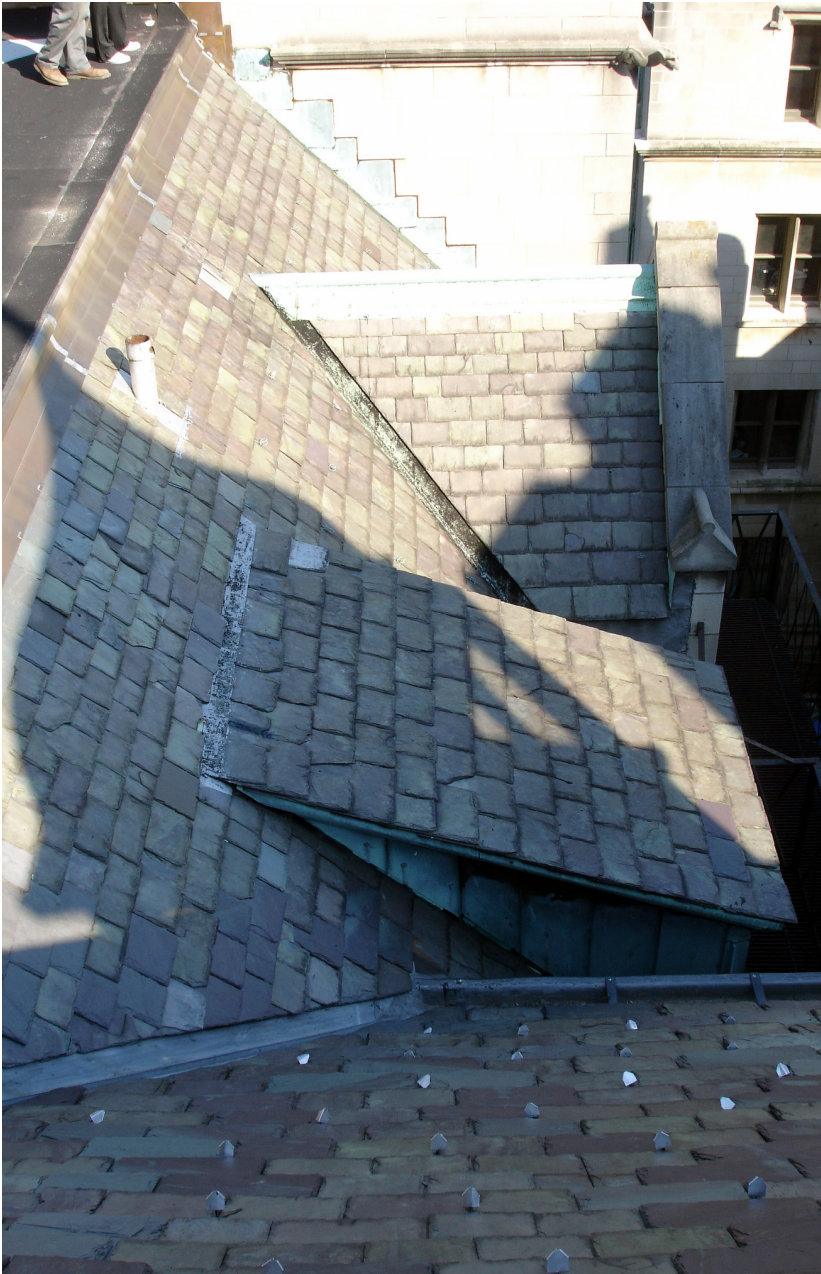
493 College Street has a slate roof, a section which was replaced in 2007. A section on the south side appears to be original, probably installed when the building was constructed. The original south facing section is made primarily of Vermont mottled green and purple slate of uniform lengths and random widths, with open copper valleys and copper ridges. This south facing original roof is in need of repair . There are 8-10 slates which need replacement. The mottled green and purple slates on this roof are known to have exceptional longevity. Such roofs are therefore highly restorable.

C8: overview of original slate, south side

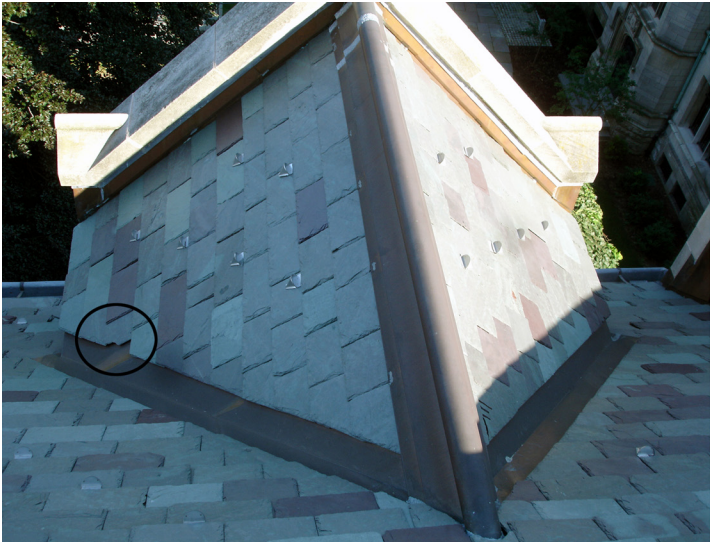
C11: missing slate

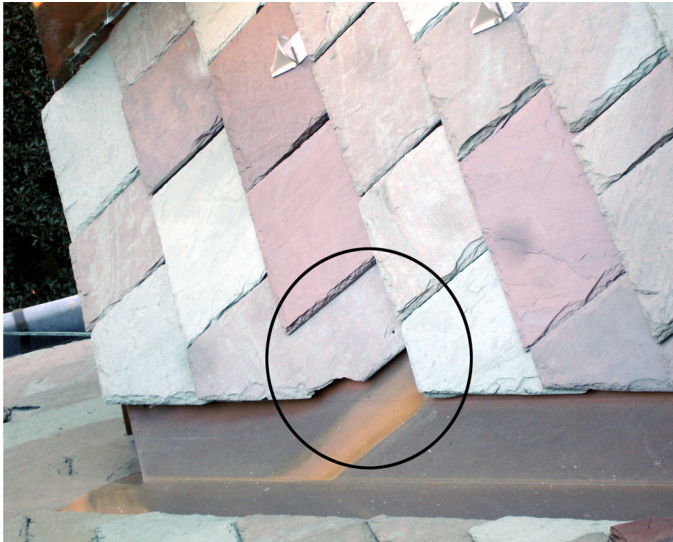
C11: close up of missing slate

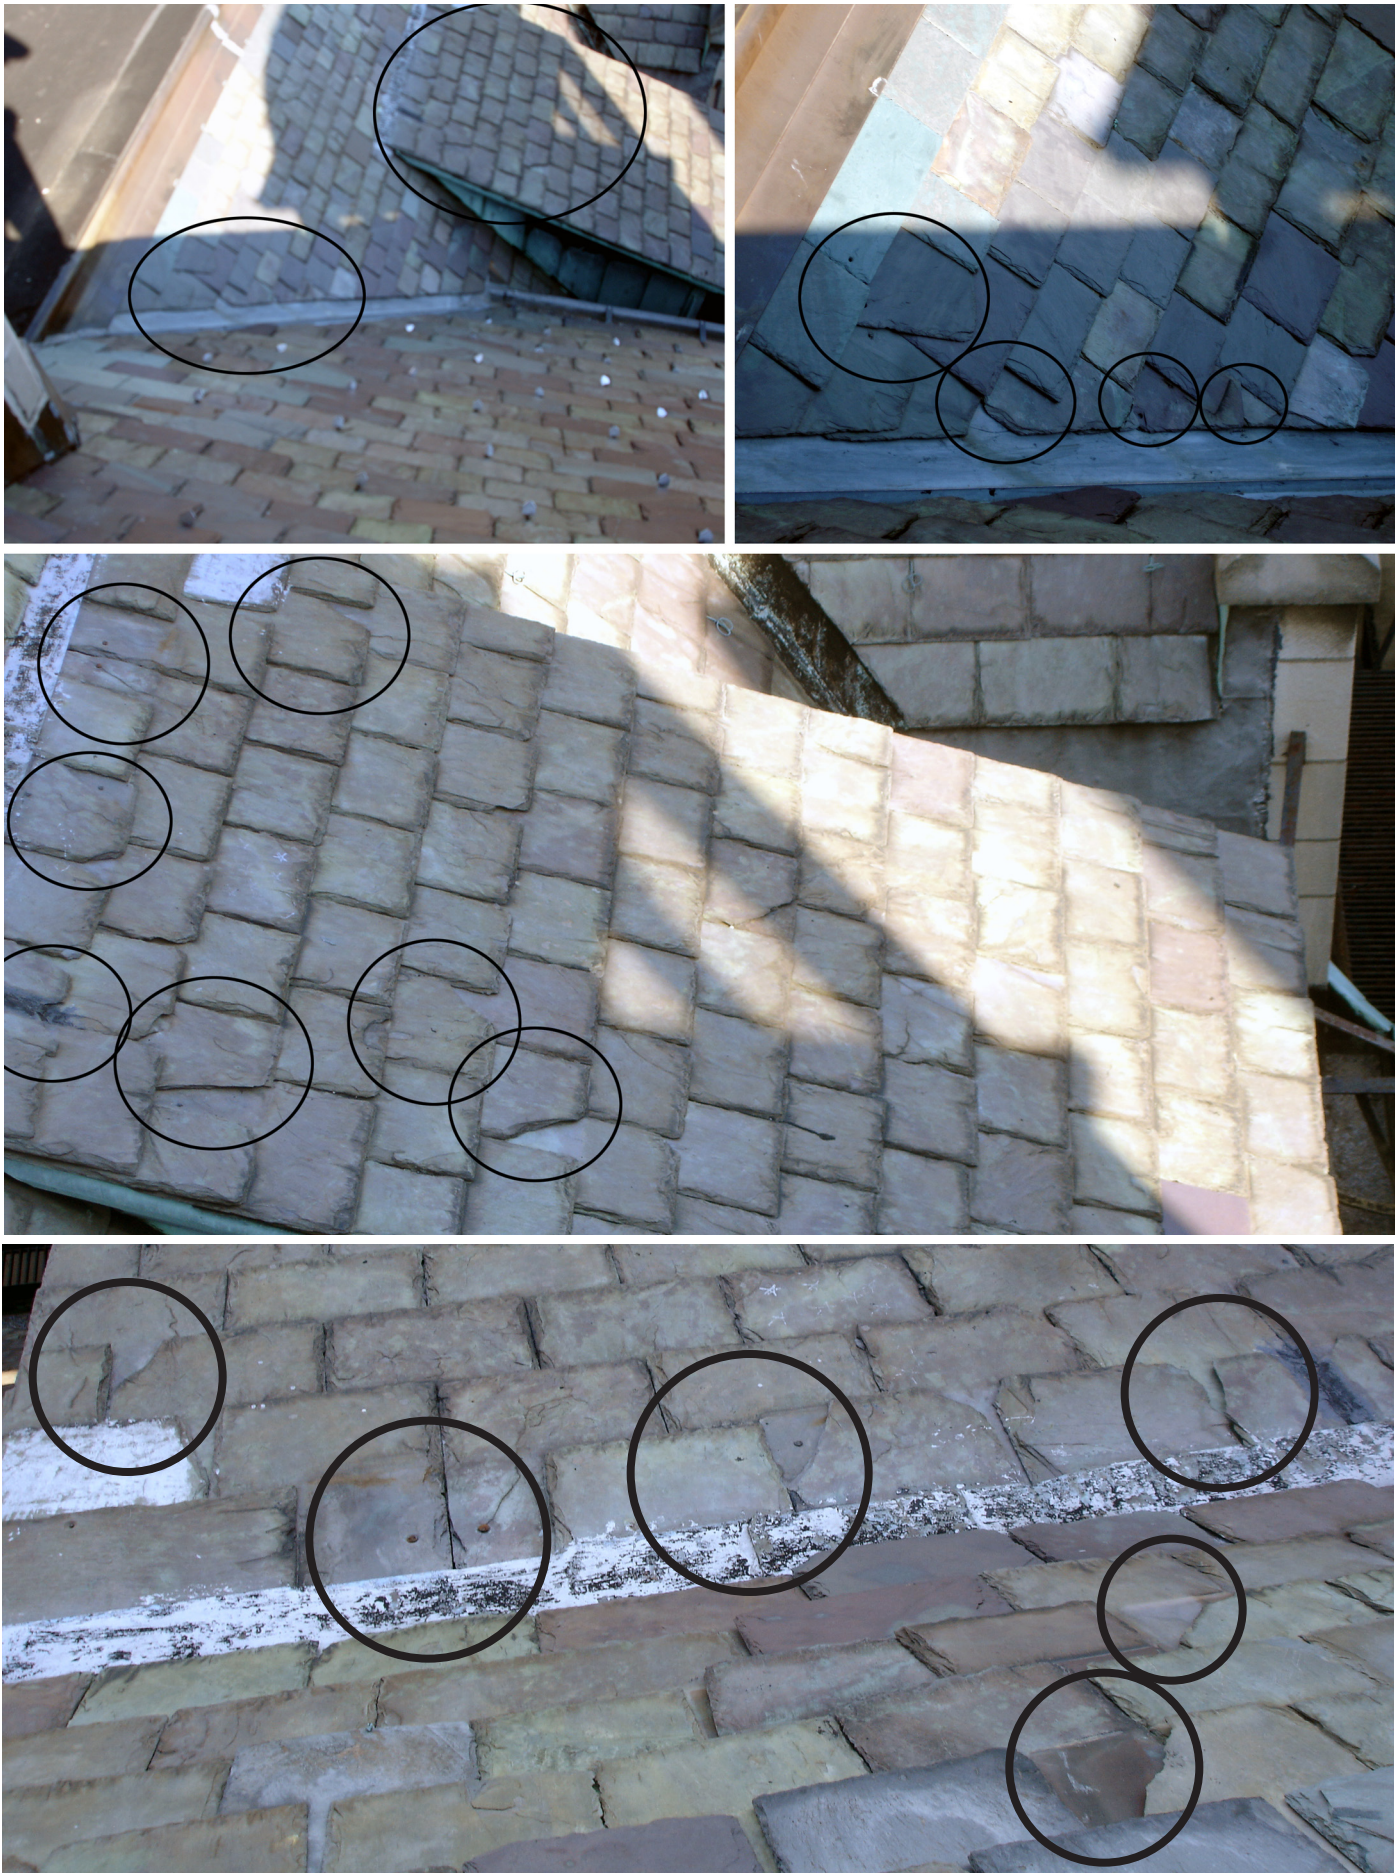
C12: missing and broken slate, south side of original roof
