What are the effects of hail on residential roofing products?

This article examines the sometimes-devastating effects that hail can have on asphalt shingles, wood shingles and shakes, and concrete tile shingles

by Jim D. Koontz

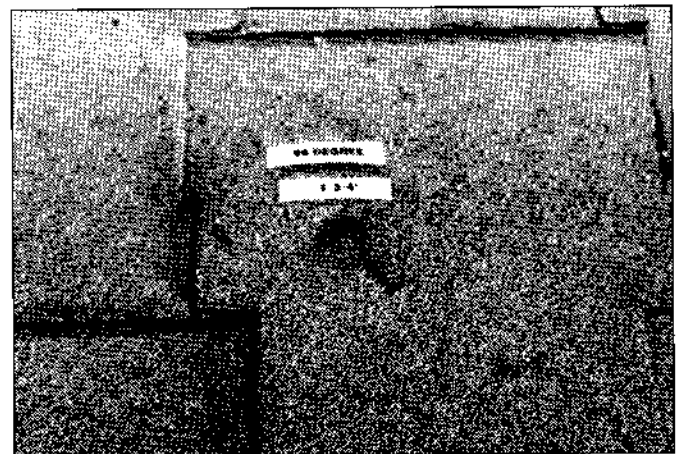
There did not appear to be a visible difference in hail resistance between organic and fiberglass three-tab products. The three-tab, assembly-type shingles, however, did have a higher hailstone resistance than T-lock shingles (see Photo 4). This increase in hail resistance appears to be a result of the smoother, flatter installation of the three-tab shingles.

Photo 4: A 1 3/4-inch hailstone impacted this T-lock shingle at a 90-degree angle.

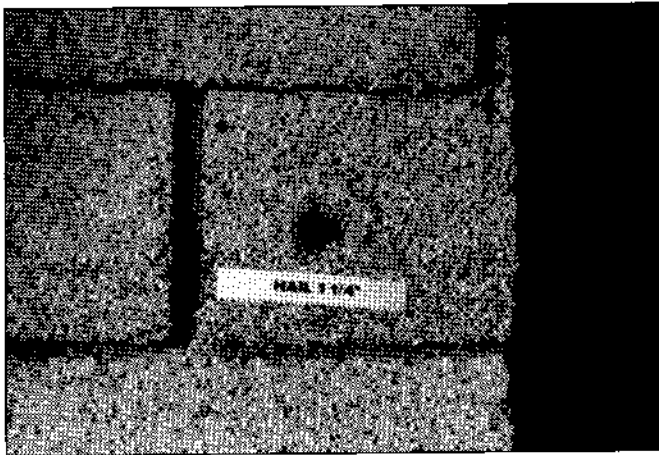
The older, organic three-tab and T-lock shingles exhibited a very low threshold of hail resistance (see Photo 5). As shingles age, asphalt within the shingle obviously hardens and becomes somewhat more brittle. This creates a situation in which tow residences could be next door to one another, and one residence could sustain damage to a slightly older roof, while the other residence could have virtually no damage with a new roofing system.

Photo 5: 1¼-inch hailstones impacted on an older, three-tab shingle.

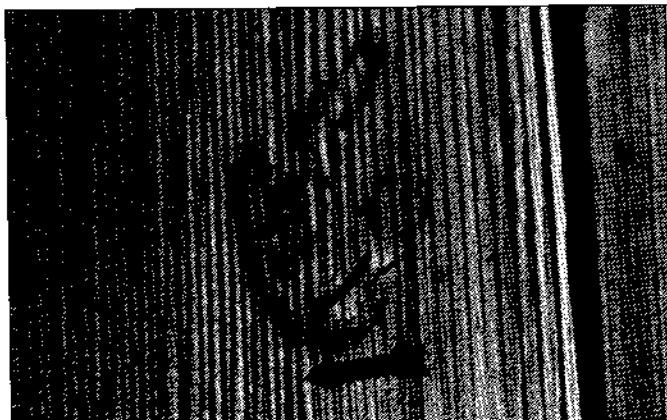
When the wood shingles (Targets No. 15 and 16) were impacted with hailstones 1 ¼ inches (44 mm) or larger, the shape of the indentation was not uniform (see Photo 6). This was due to two factors: One, the

Photo 6: Irregular indentation of hailstone impacted on a wood shingle.

hail tends to crush and rotate somewhat as it impacts the shingle; two, because the surface of the wood shingle is irregular, the indentation becomes erratic.

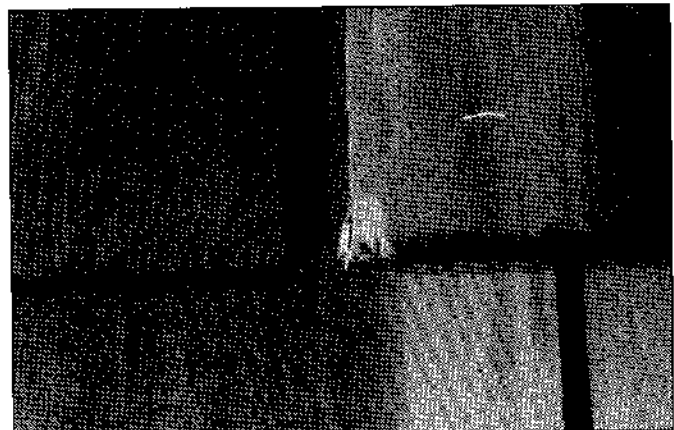
The thicker wood shingles did not necessarily result in higher hailstone resistance. The thinner red cedar shingles (¾ inch or 9.5 mm) with smoother surfaces and a greater uniformity in the substrate produced hailstone resistance equal to the thicker shingles. Some indentation of the wood shingles did occur at the leading butt edge and at the joint of the shingles. The bulk of this damage is somewhat superficial, and began at a fairly low threshold of kinetic energy (see Photo 7).

Photo 7: Wood shingle indentation at butt edge.

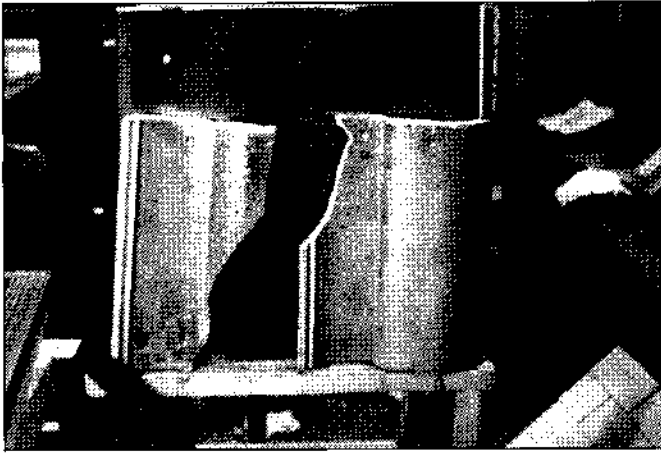
The three concrete tile targets all exhibited fairly high degrees of hail resistance. Fracture/breakage did not occur with the 2 ½-inch (64-mm) hail at a 90-degree angle of impact. Fracture/breakage did occur, however, when the velocity was increased to 131 feet per second (40 meters per second) or 89 mph, resulting in kinetic energy of 71.49 feet per second (96.9 joules—see Photo 8).

Photo 8: Fracture of a concrete tile.
