What are the effects of hail on residential roofing products?

This article examines the sometimes-devastating effects that hail can have on asphalt shingles, wood shingles and shakes, and concrete tile shingles

by Jim D. Koontz

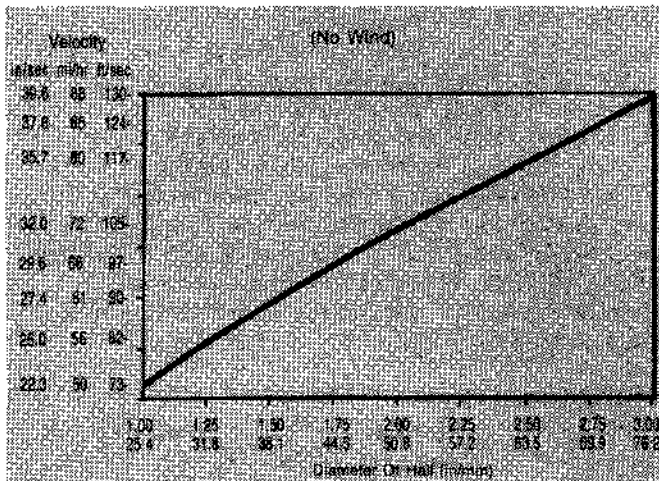
4. Terminal velocity: The terminal velocity of hailstones was originally determined by J.A.P. Lauri. These terminal velocities (see Figure 1) have been used throughout the industry in other research, particularly that performed by the National Institute of Standards and Technology (formerly the National Bureau of Standards).

Figure 1: Terminal velocities of hail.

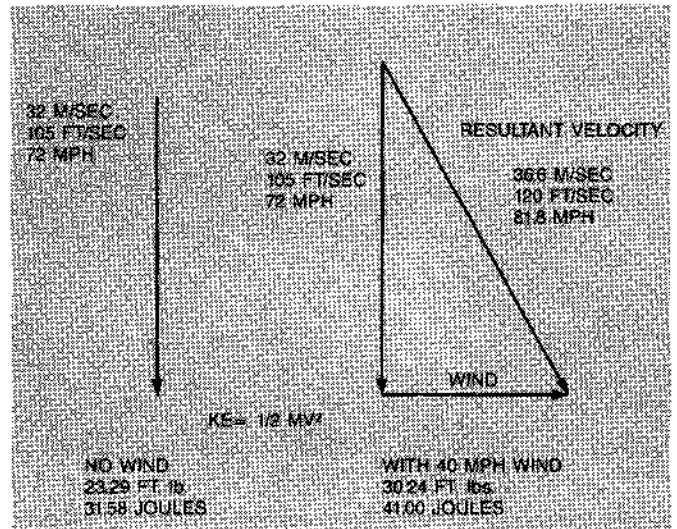
Figure 2: Effect of 40-mph wind on 2-inch-diameter hail.

force (41.0 joules), or an increase of 30 percent in impact energy. By varying the horizontal wind factor, the ultimate impact energy can be varied dramatically (see Figure 2).

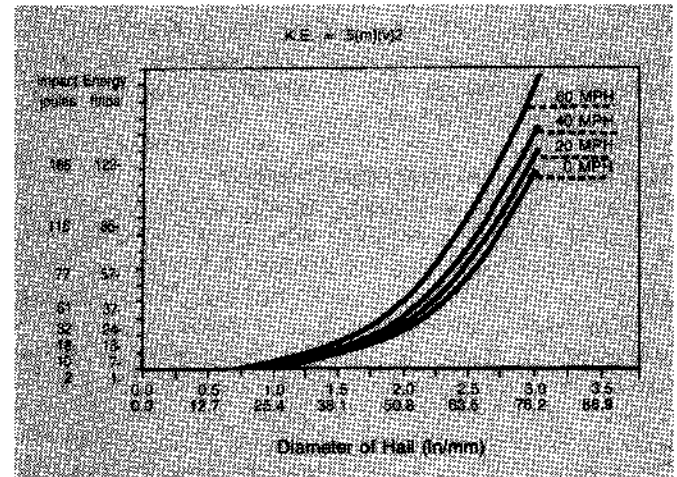
In reviewing this initial data, it is also interesting to note the overall difference in impact energy between hailstones with diameters of 1 inch (25.4 mm) and 2 inches (51 mm). Increasing the diameter of the hail from 1 inch to 2 inches increases the ultimate impact energy from less than 1 foot per pound (1.4 joules) to approximately 22 foot per pound (29.83 joules—see Figure 3).

Figure 3: Impact energy of hail.

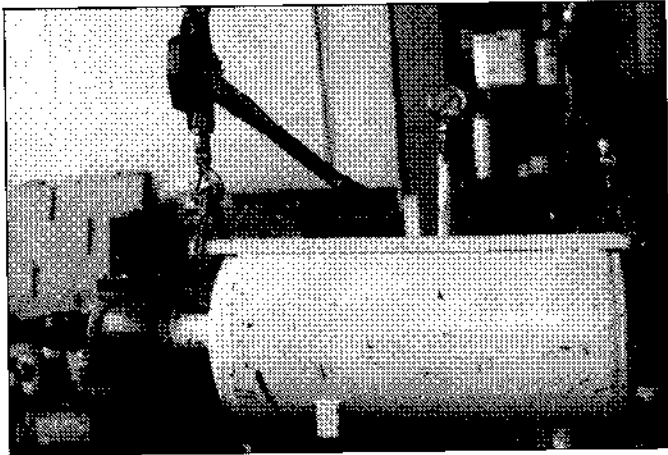
Photo 1: Hail gun with quick-release valve.

This gun consisted of a pressurized air tank fitted with a quick-release, electronically actuated valve (see Photo 1). The barrels of the hail gun were interchangeable to accommodate the size of the hail, which was formed in molds (see Photo 2).

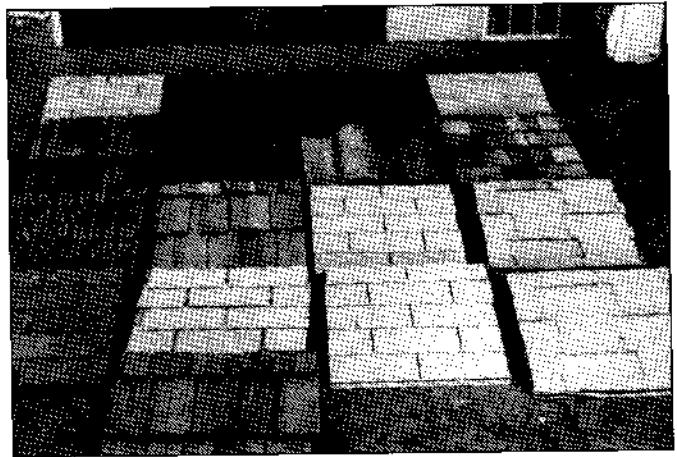
Photo 3: The hail targets.

Nineteen roofing assemblies were tested for resistance to hail damage (see Photo 3). The substrate of 18 of the samples was $\frac{1}{2}$ -inch (12.7-mm) CDX plywood. One sample was tested with $\frac{1}{2}$ -inch (12.7-mm) OSB decking.

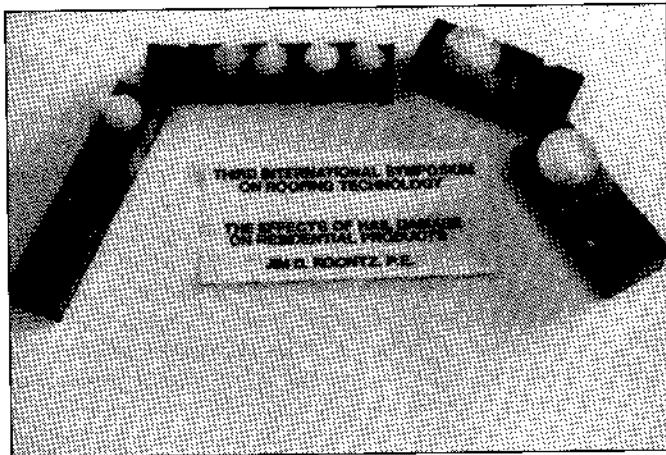
Photo 2: Hail molds.

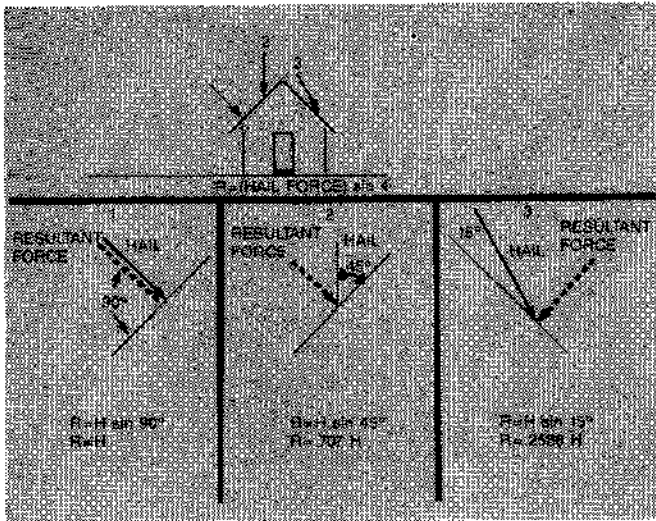
Each sample was impacted by hail 15 times. This included five different sizes of hail— $\frac{3}{8}$ inch (19 mm), $1\frac{1}{4}$ inch (32 mm), $1\frac{1}{2}$ inch (44 mm), 2 inch (51 mm) and $2\frac{1}{2}$ inch (64 mm)—impacting at three different angles of impact (15, 45 and 90 degrees—see Figure 4). A variation in the angle of impact from 15, 45 to 90 degrees produces a resultant force ranging from 25.88 percent, 70.7 percent and 100 percent, respectively.

Figure 4: Angle of impact of hail.
