Roof Survey Report

September 24, 2008

At the request of XXXXXXXXXXXXXXX, of XXXXXXX University Office of Facilities, The Moriarty Corp. (TMC) conducted an investigation of the roofs of Silliman College, XXXXX University. The inspection included a complete visual survey and defect mapping of the slate and tile roofs of the college, together with the low slope flat-lock lead coated copper (LCC) roofs of the Georgians. The roofs were evaluated to provide a comprehensive profile of their current condition. Visits were made to the buildings during the week of August 18-23, 2008.

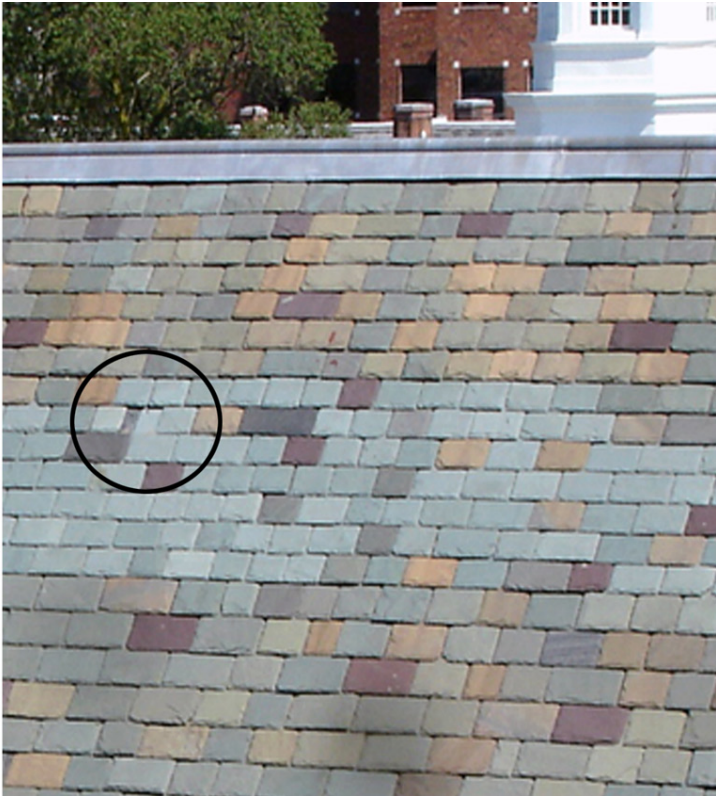
1 slate missing,
four courses
down from ridge
(B6)

B6: slate missing four courses down from ridge and nine courses down from ridge

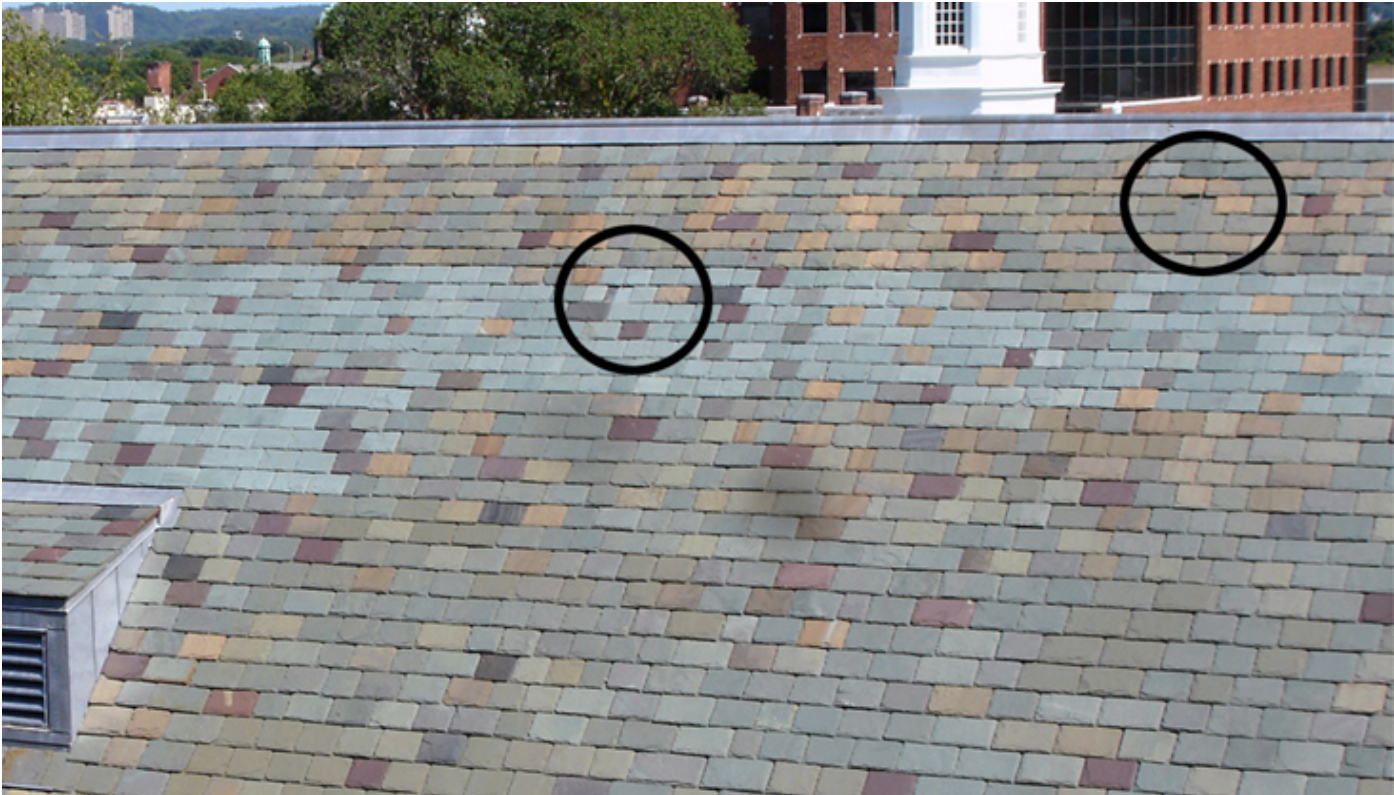
B6: close up

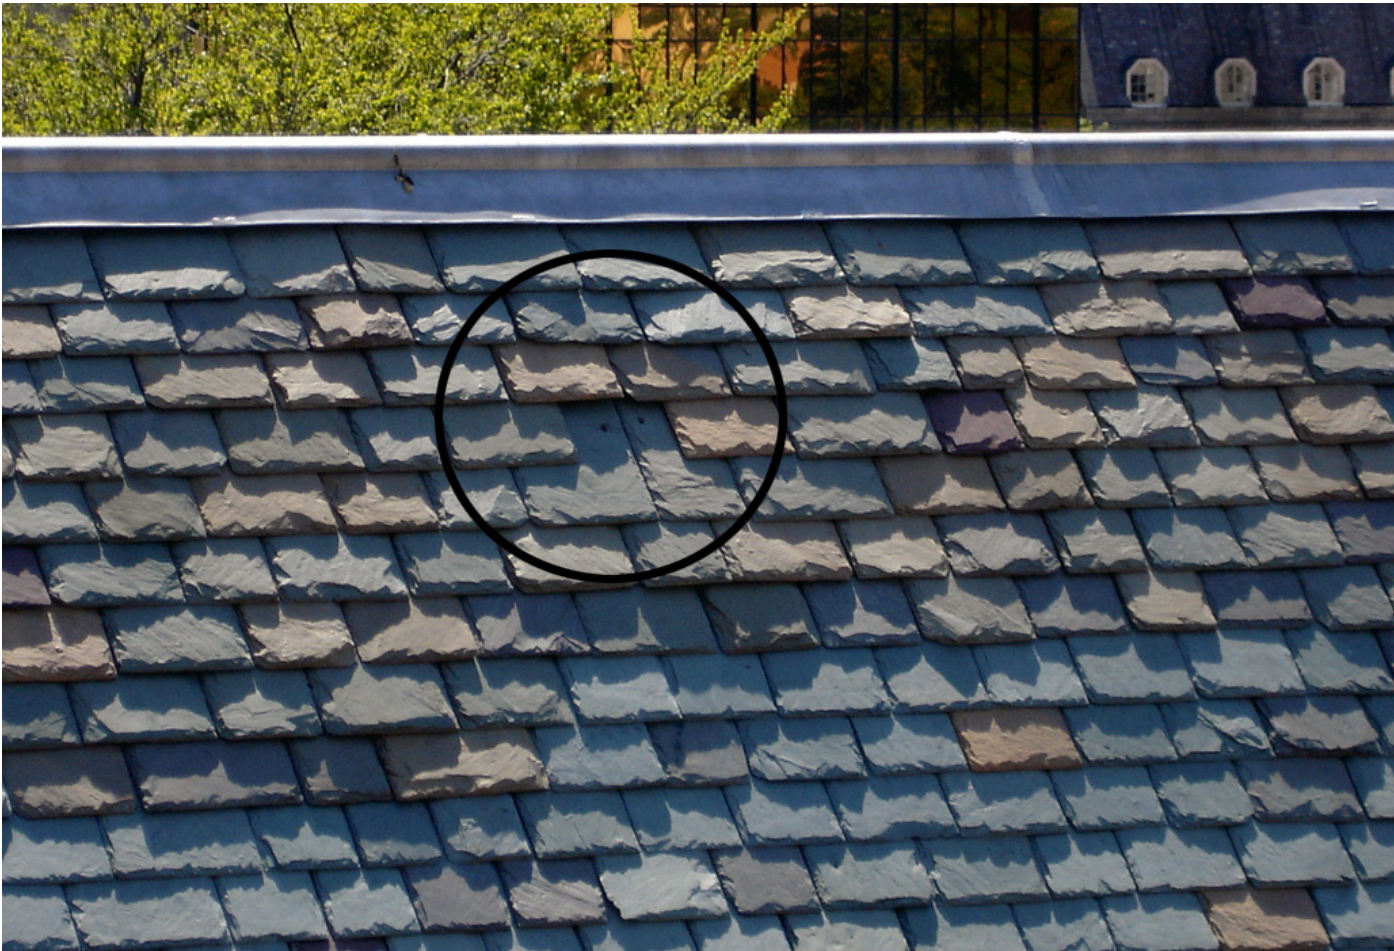
B6: close up, one slate missing four courses down from ridge

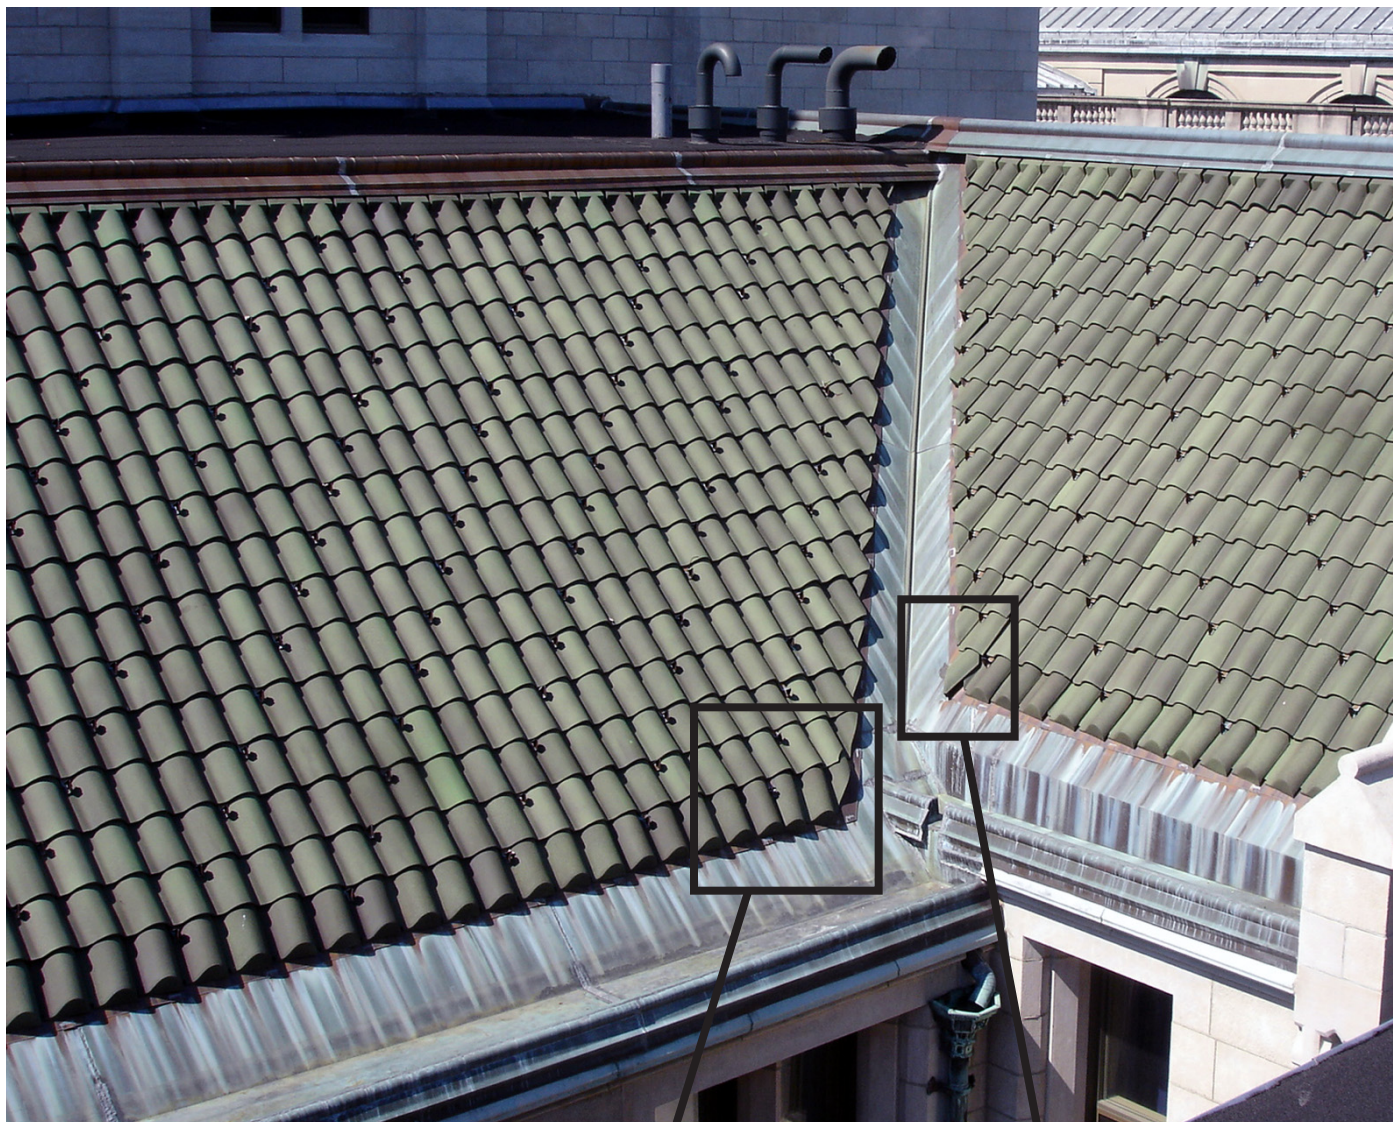
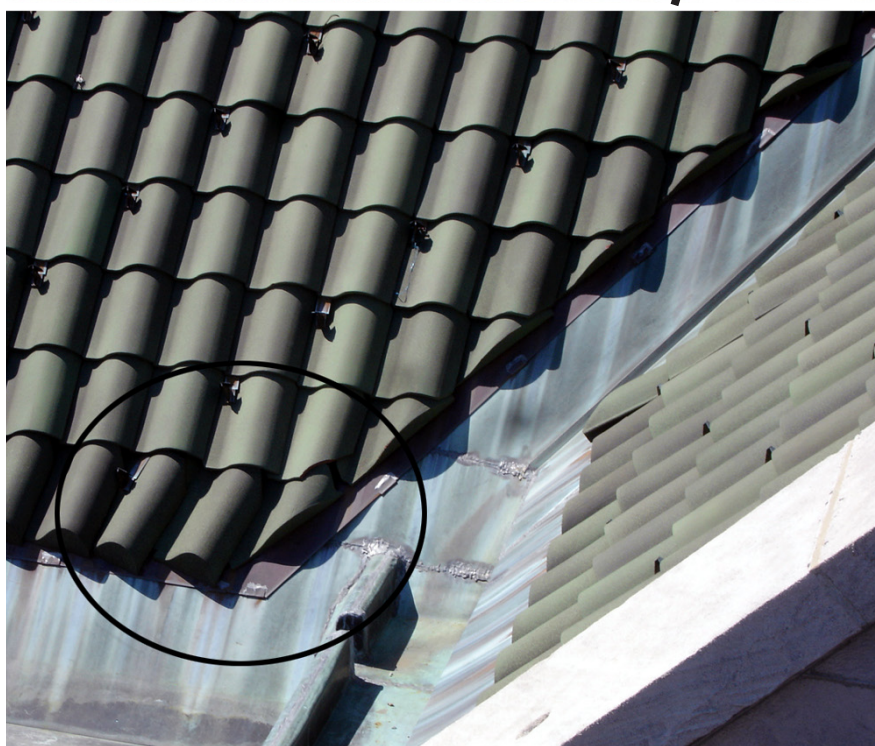
VS1: tiles slipping

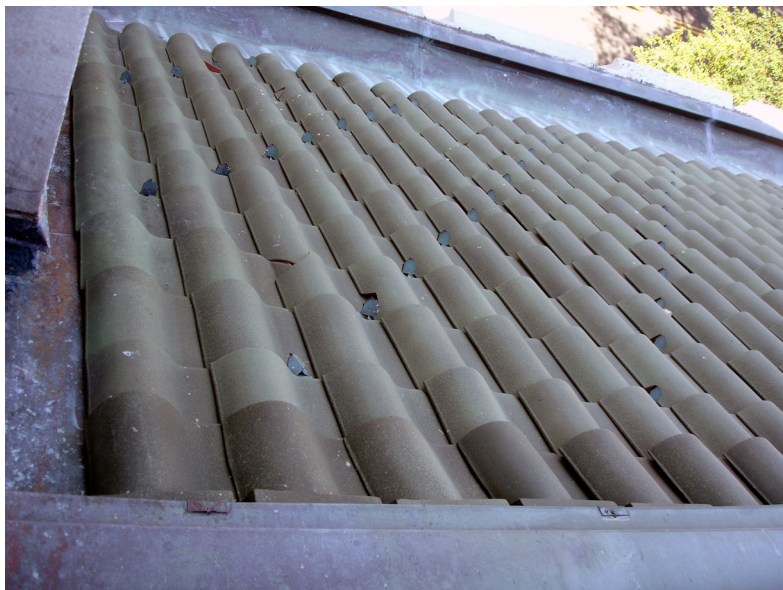
VS2: 3 broken tiles and broken snow guard

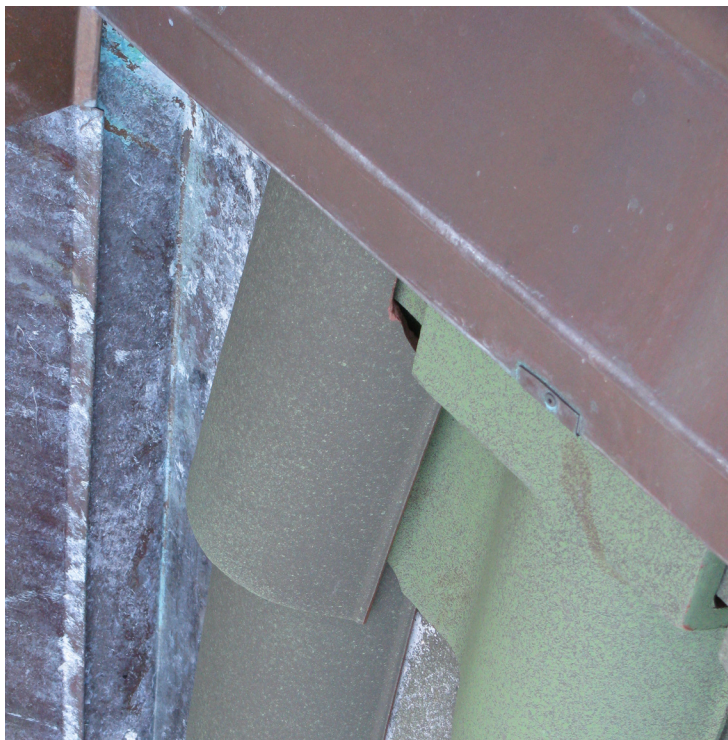
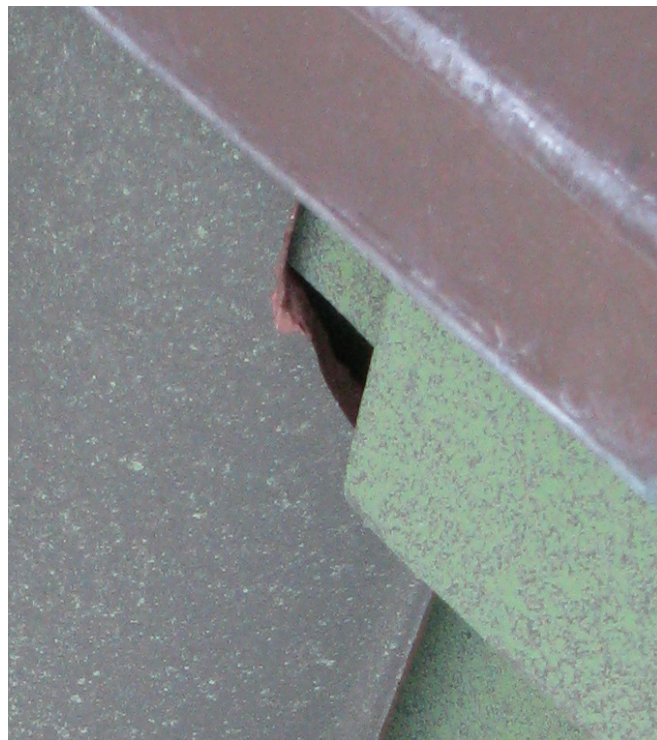
VS5: flat top tile not installed, tile loose and open to water

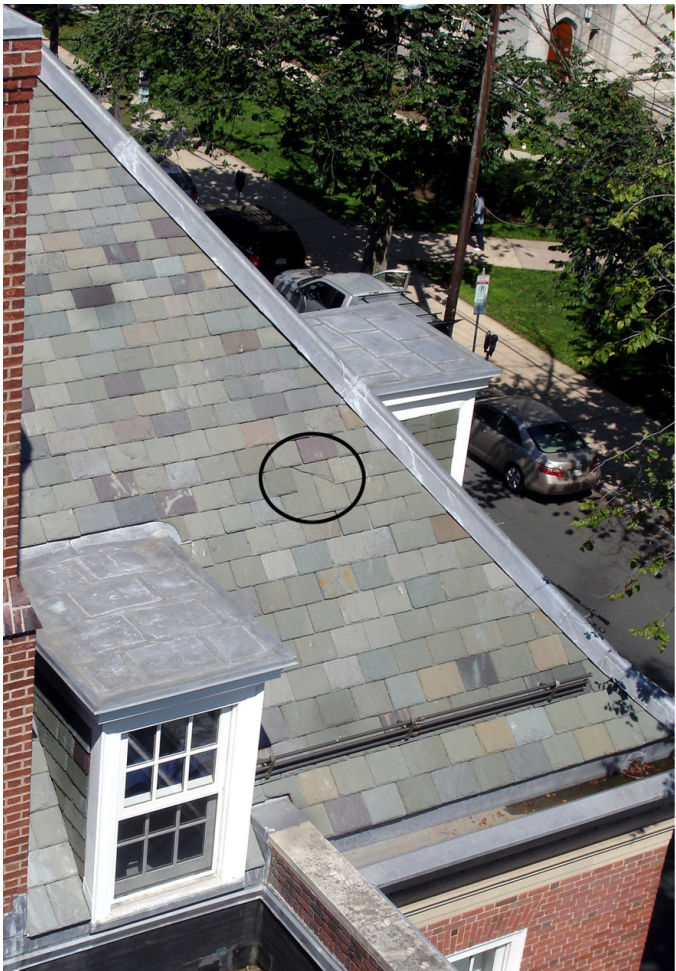
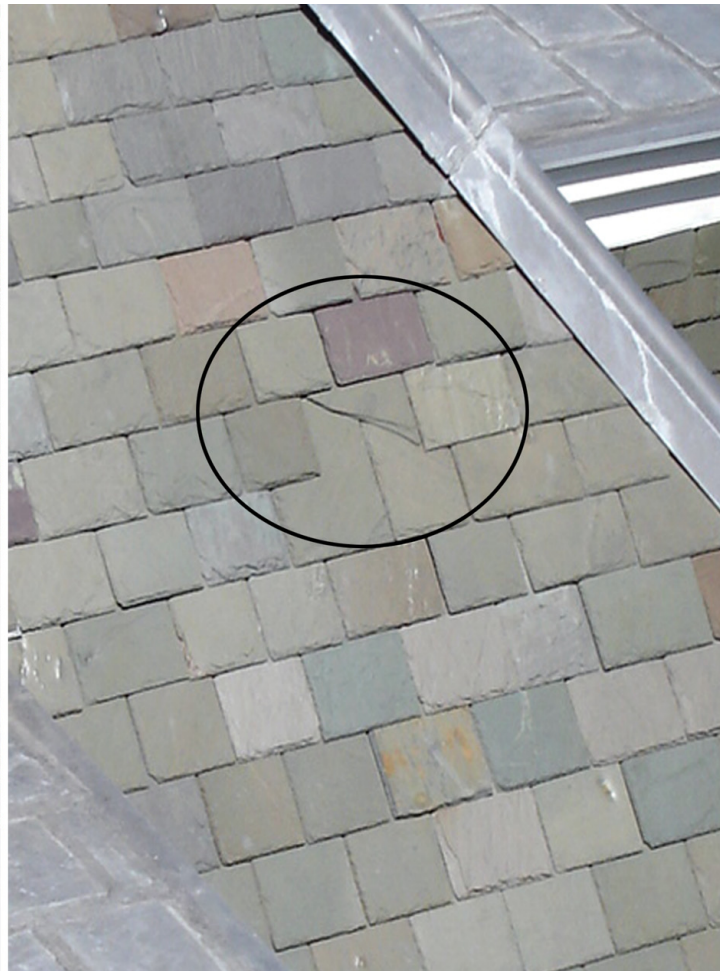
G1: one slate broken twelve courses up from gutter

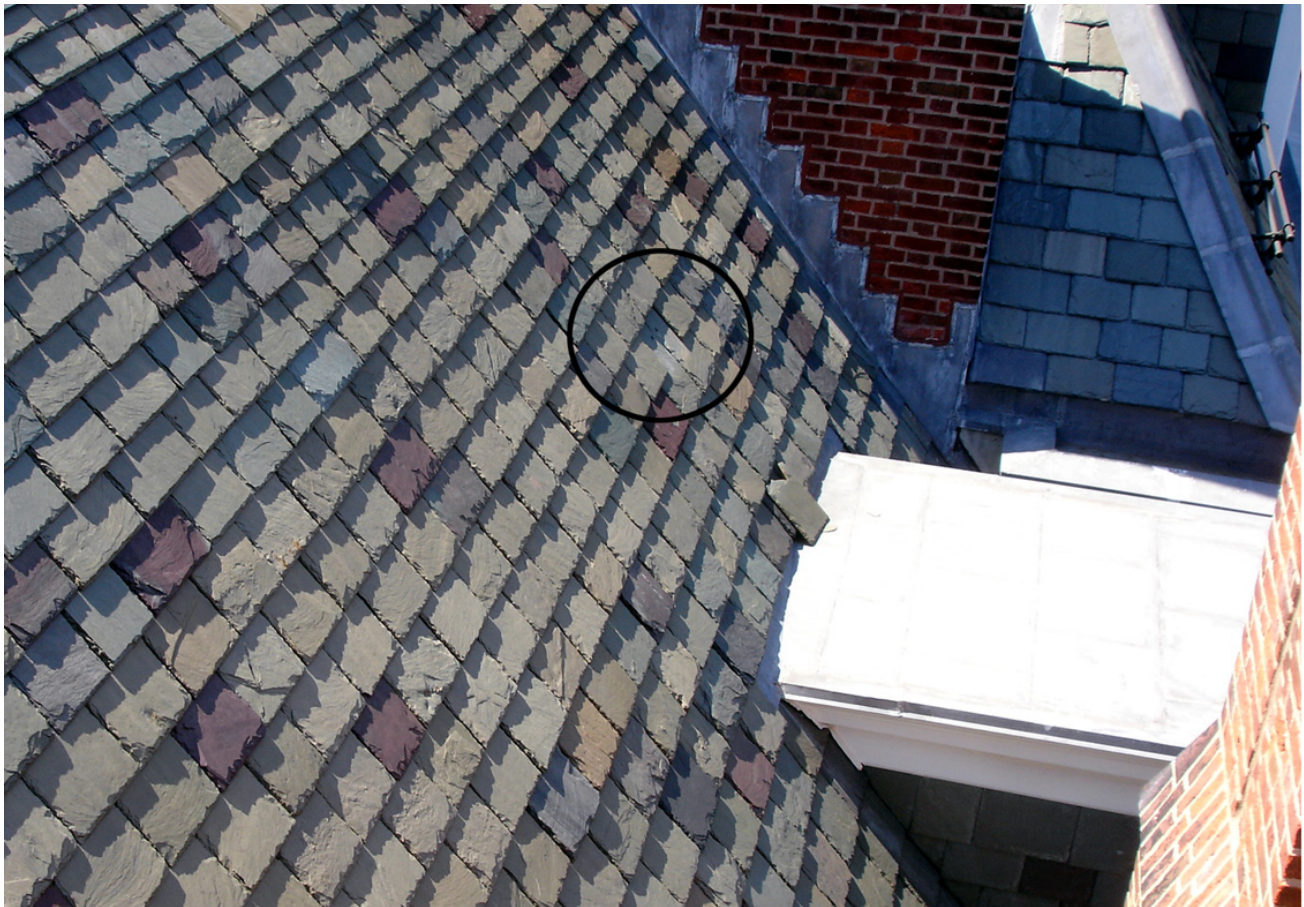
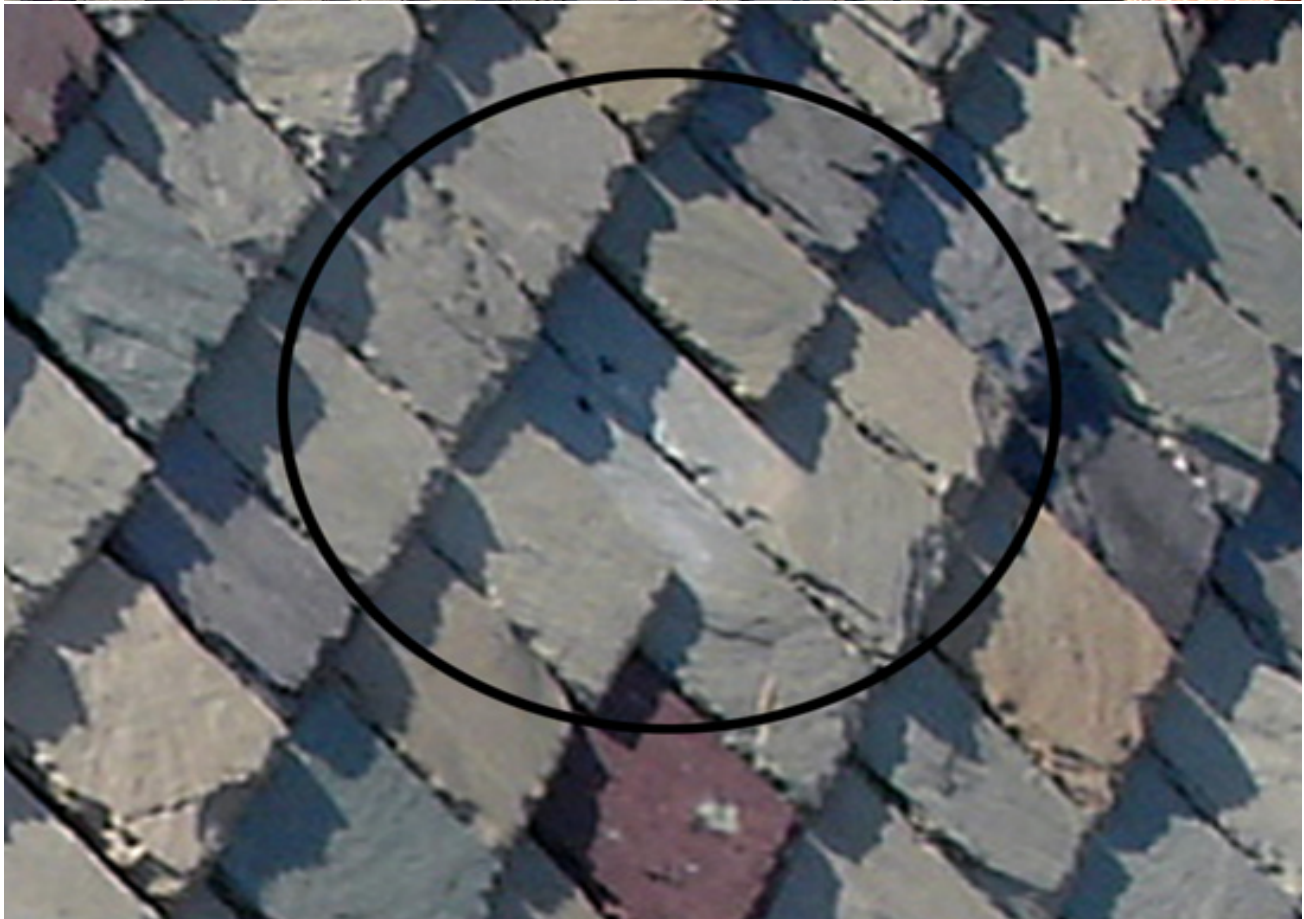
G8: one broken/ missing slate, slate resting on dormer roof

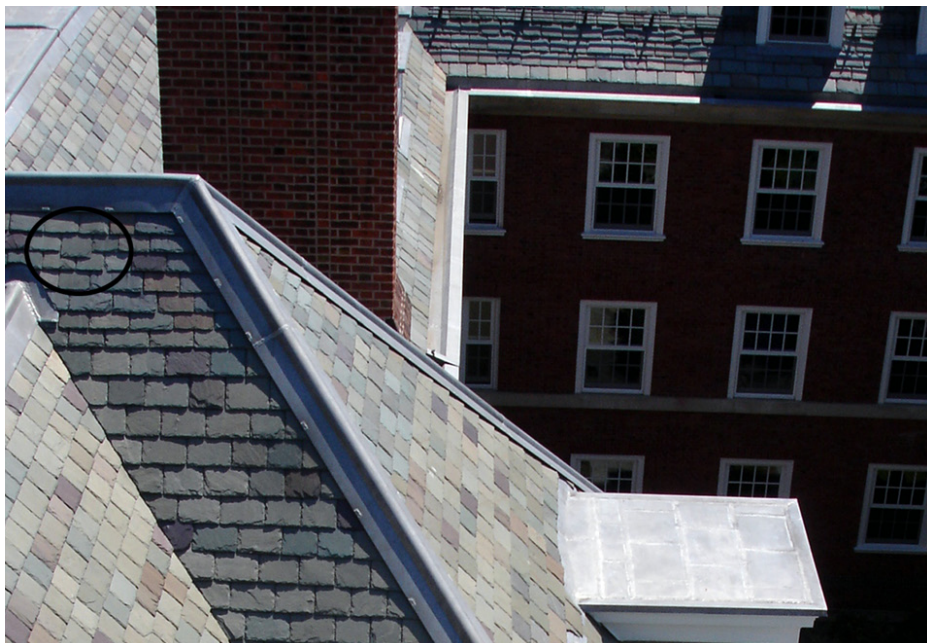
G9: one slate slipping

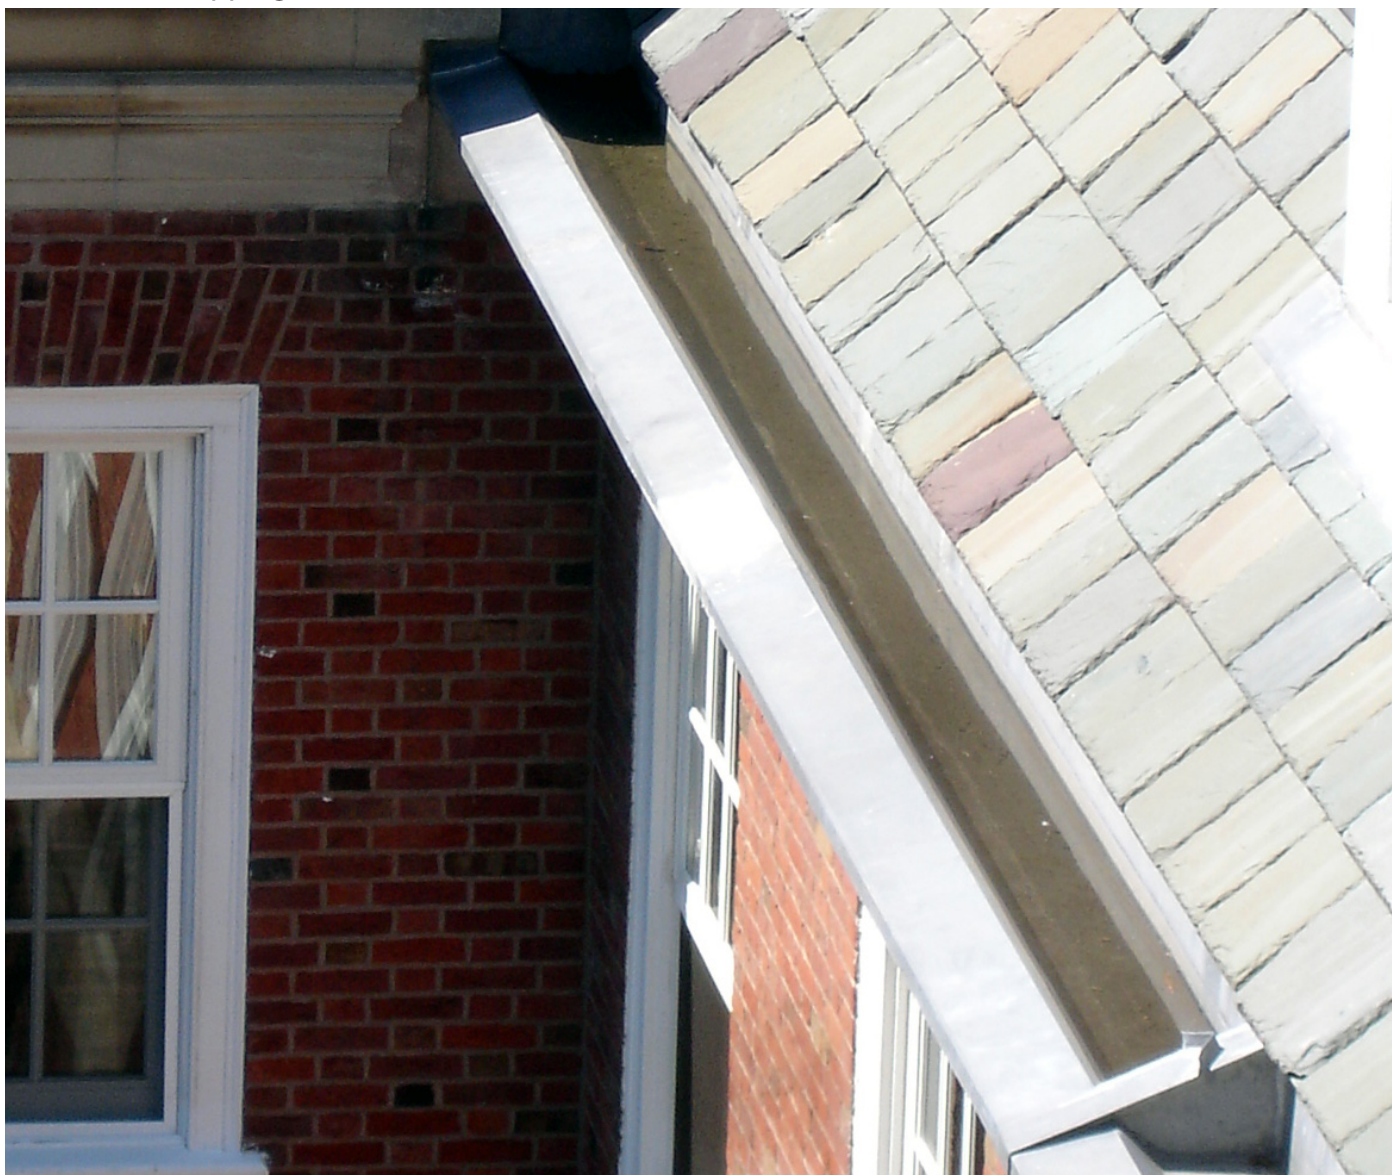
G10: blocked gutter

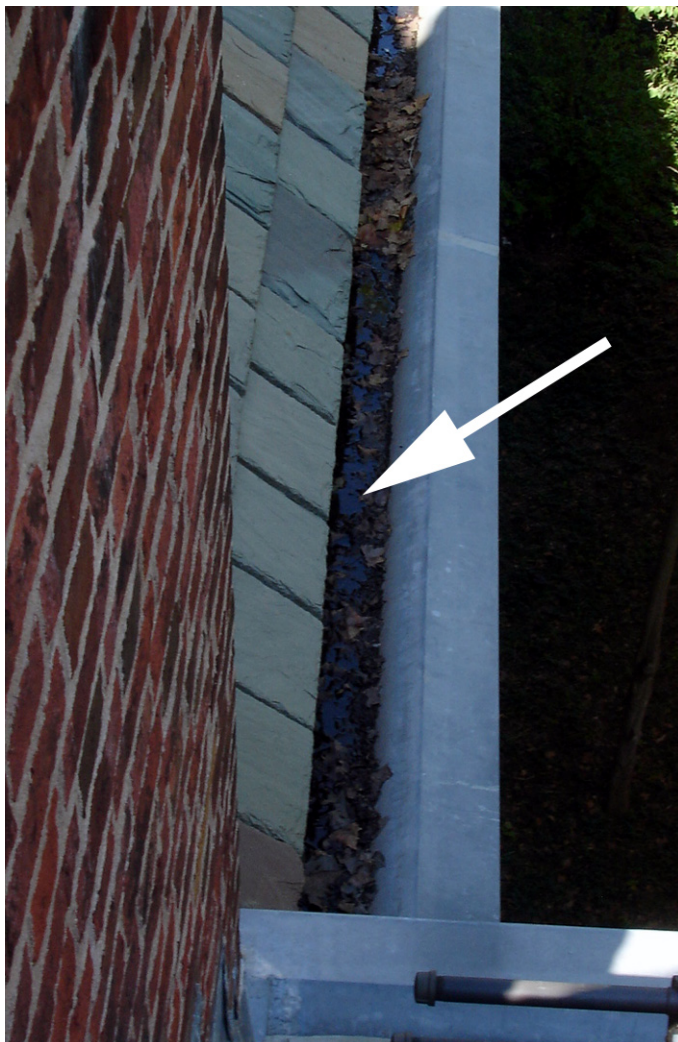
G11: debris blocking gutter outlet

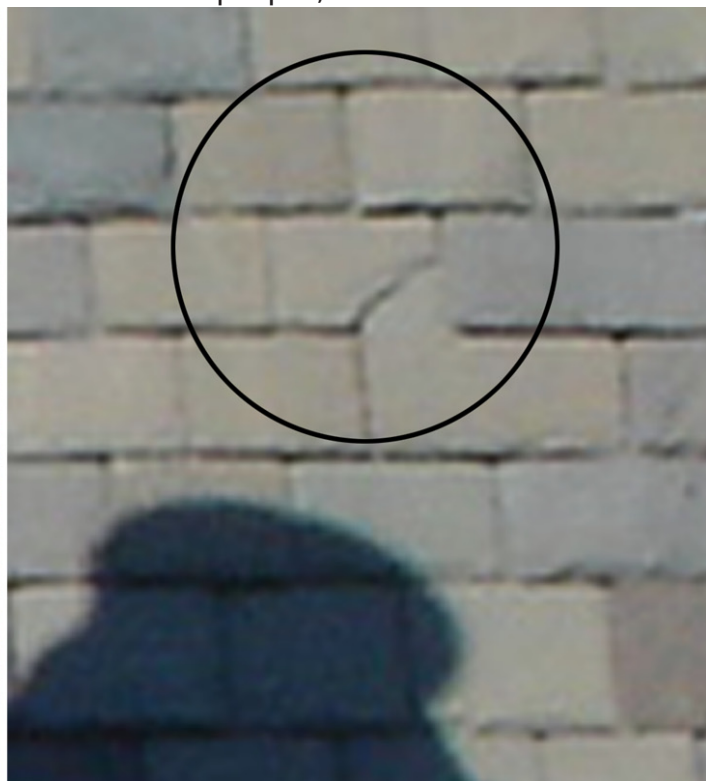
G13: slate slipping

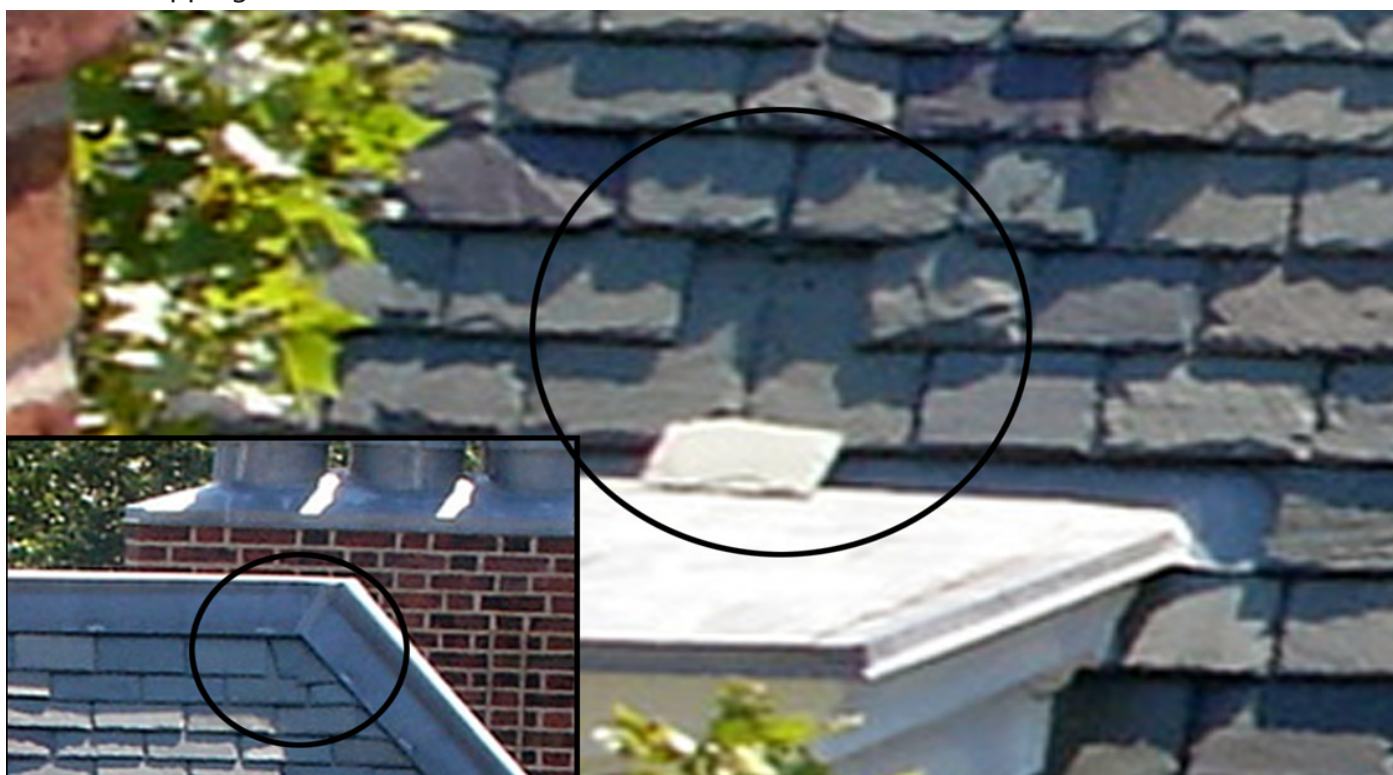
G13: slate has fallen out and is resting on dormer roof

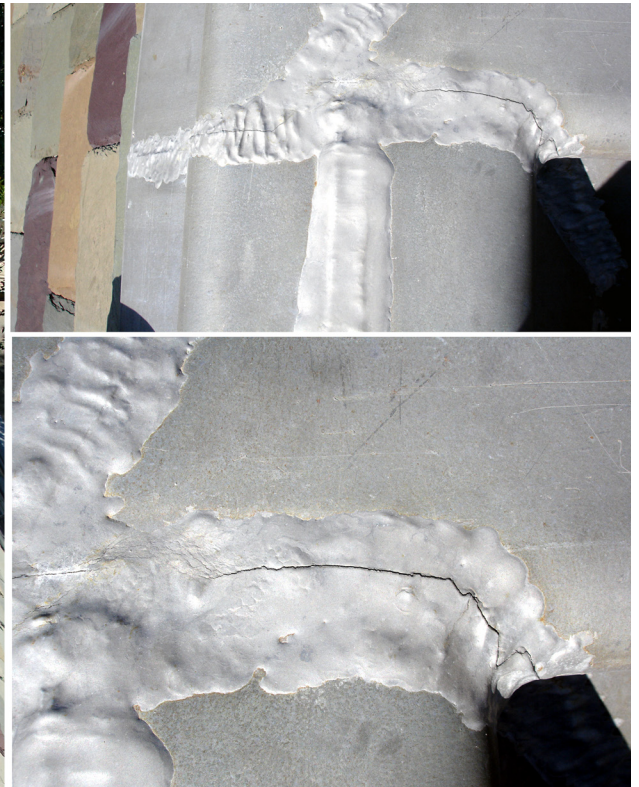
G16: close up of cracked solder joint

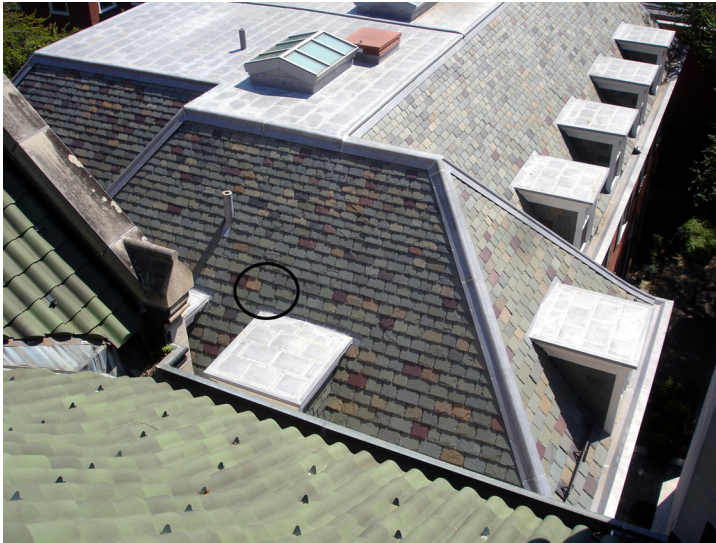
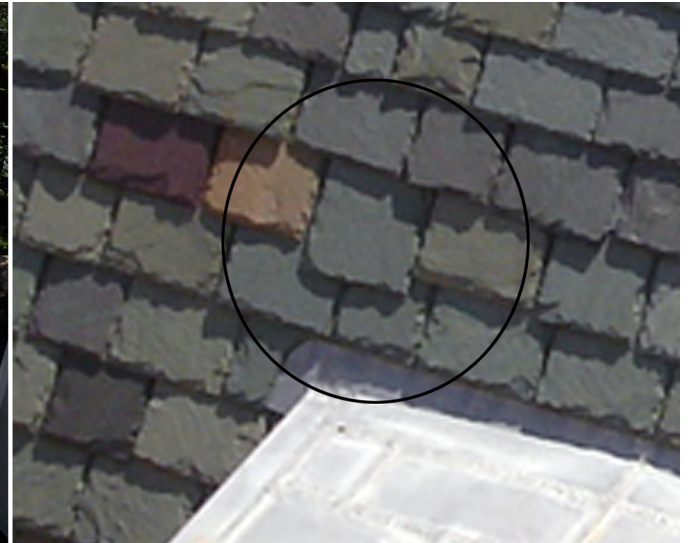
M1: slate slipping two courses above dormer

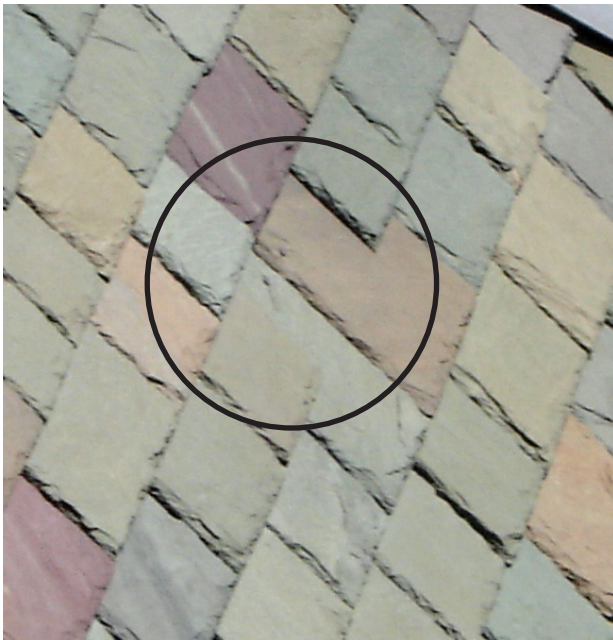
M2: slate missing

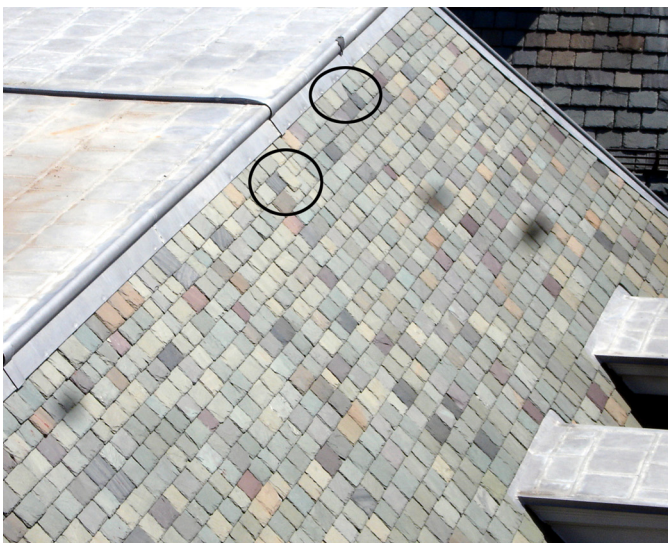
M4: slate slipping and broken

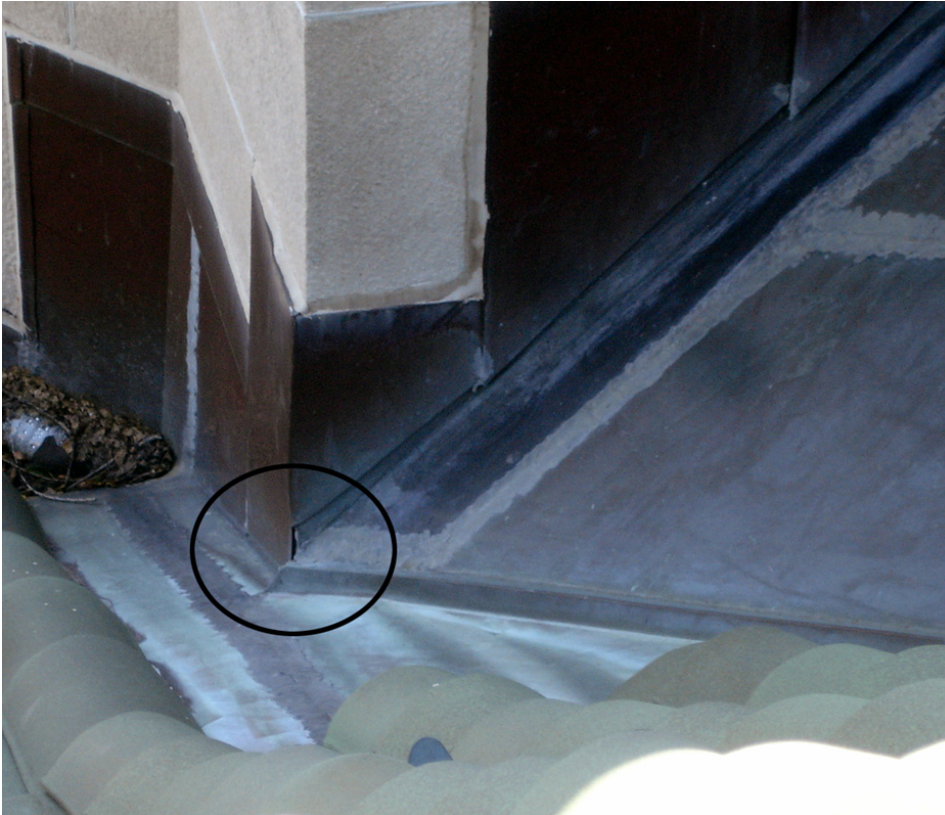
VS11: copper chimney flashing appears open at corner

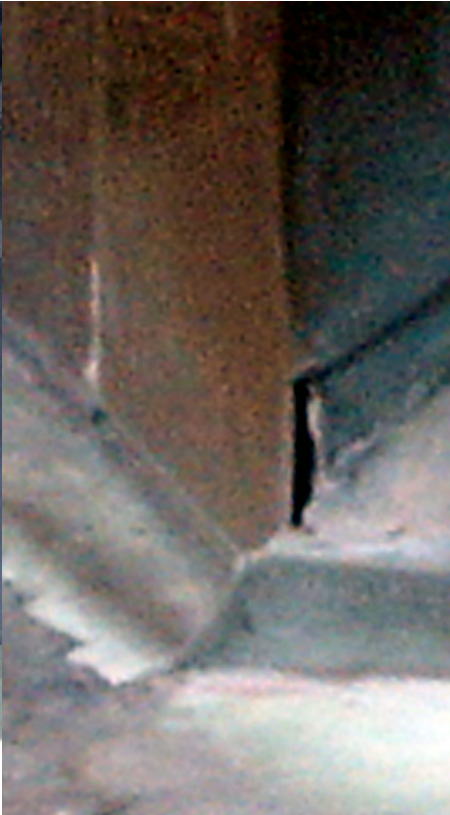
VS11: close up

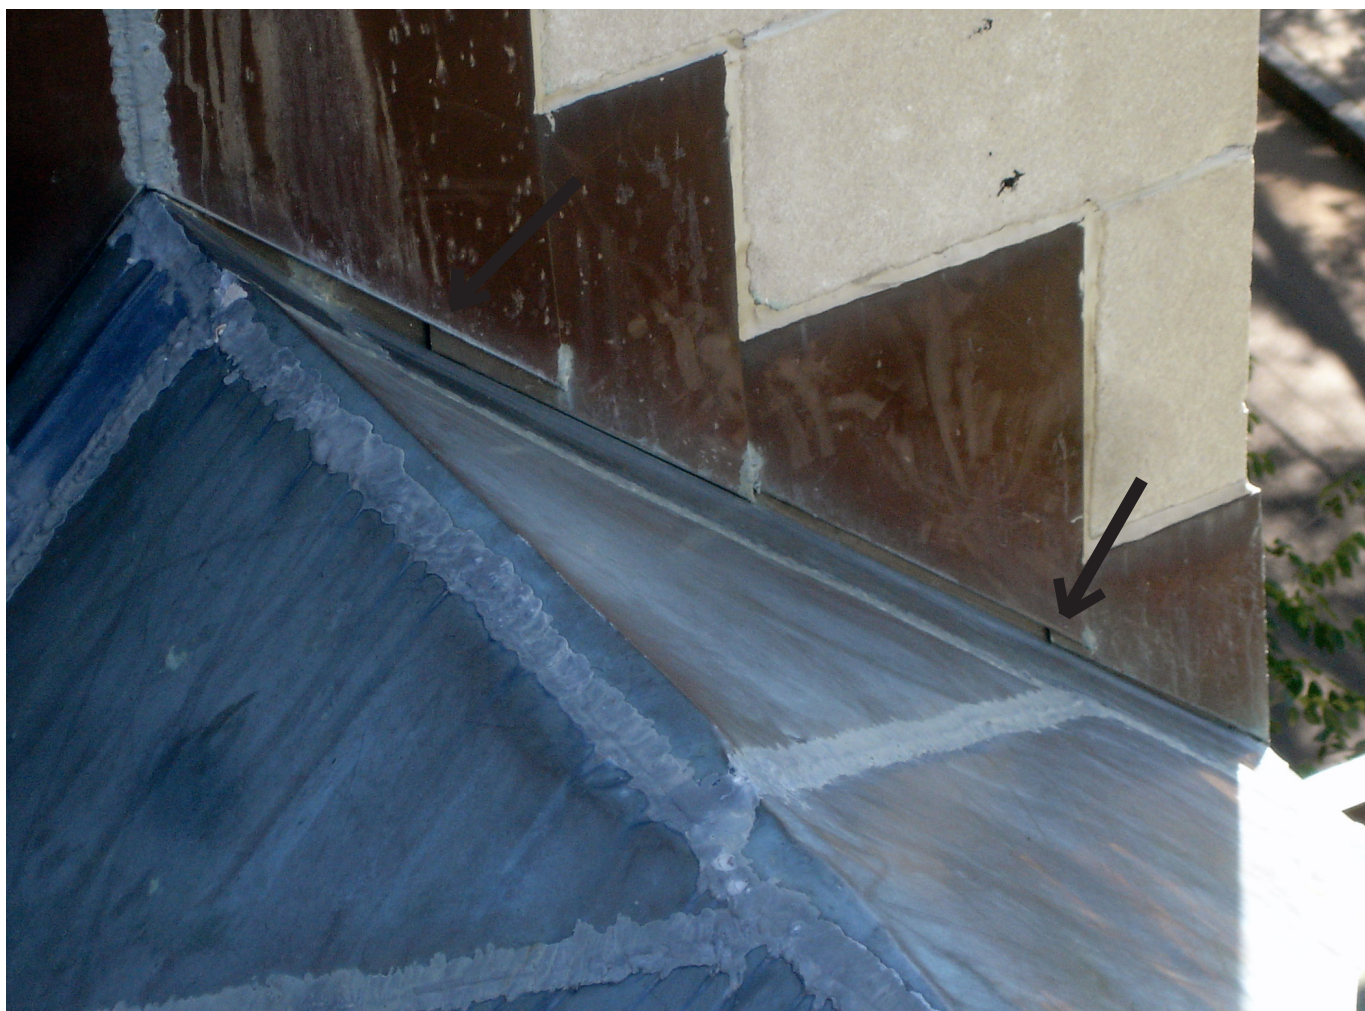
VS11: step flashing appears lapped against flow

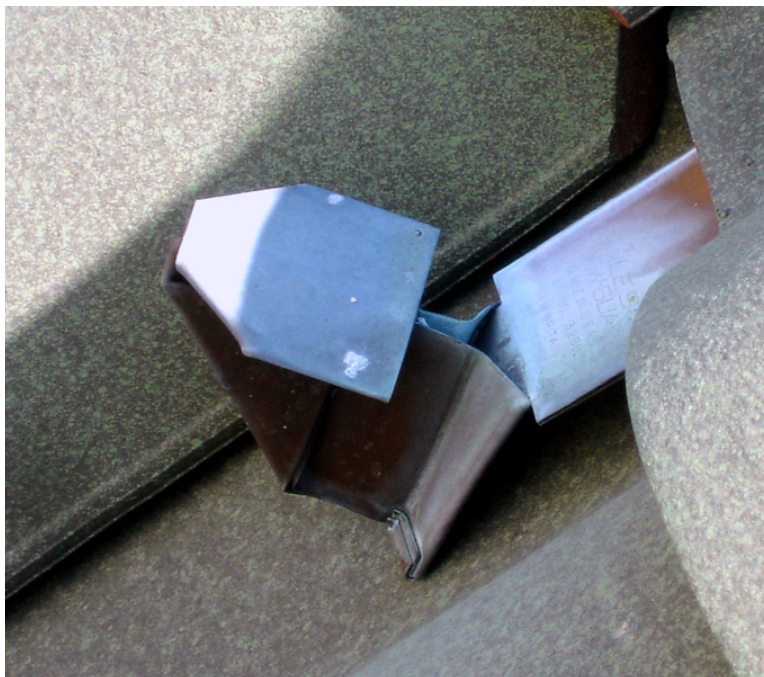
VS13: failed snow guards, random locations

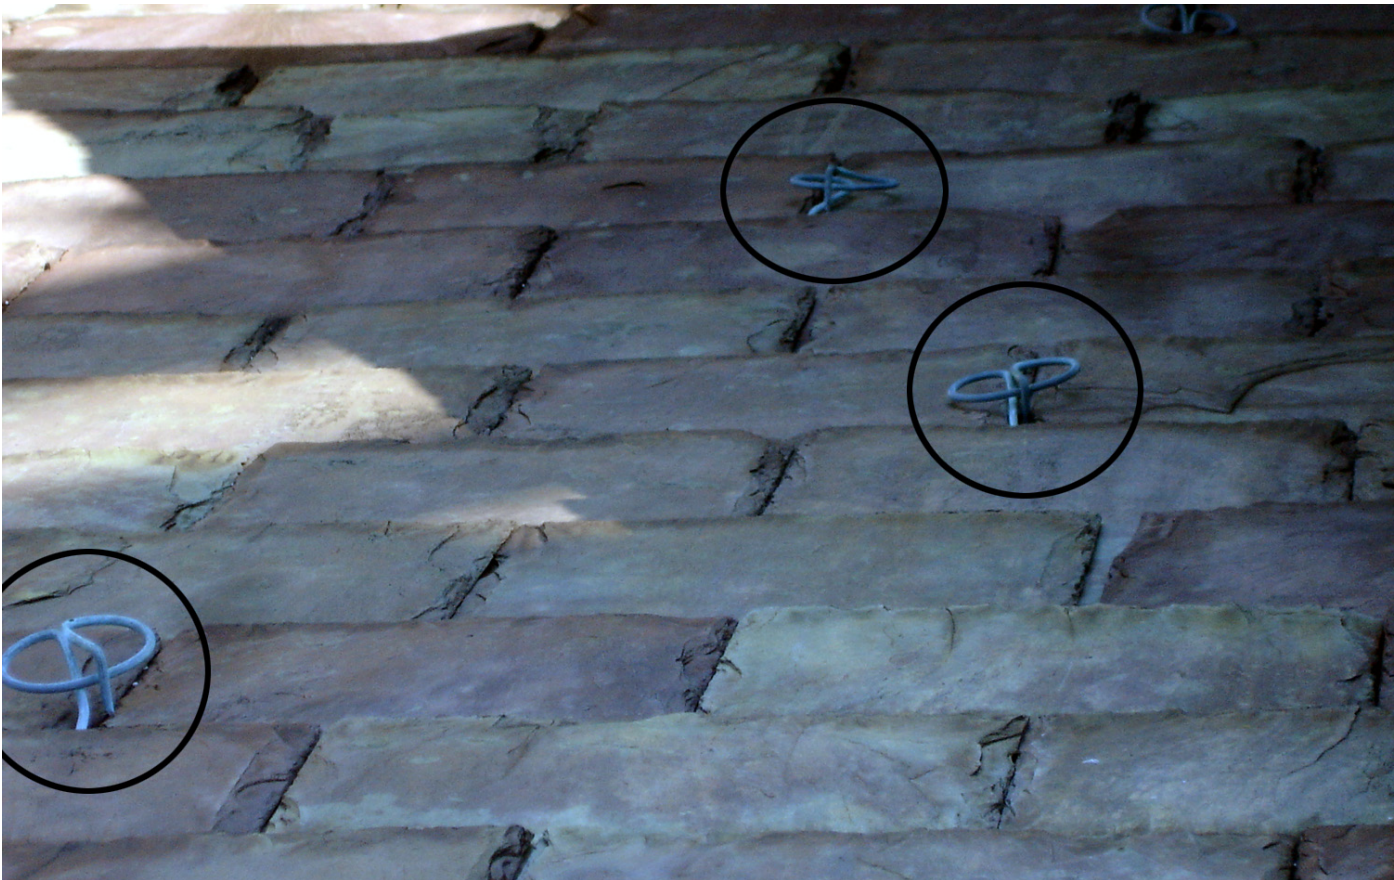
C3: flattened wire snow guards

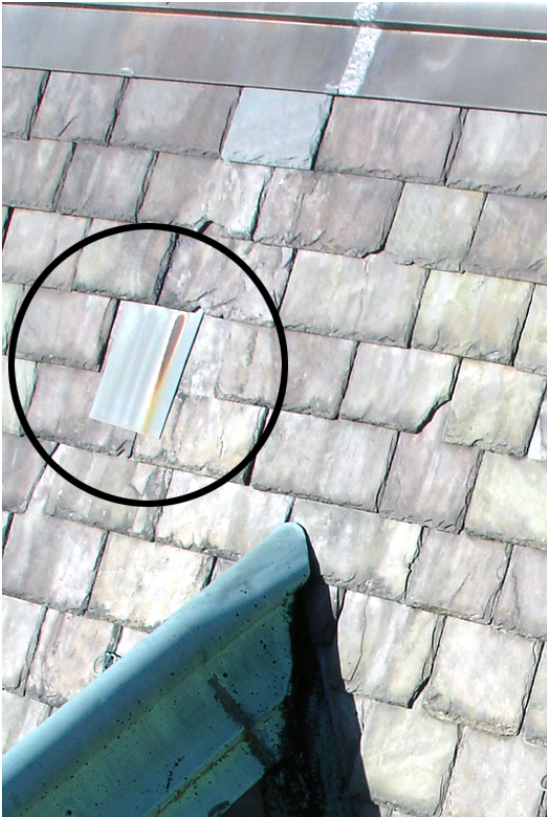
C9: missing slate
